ROSENTHAL FINE ARTS BUILDING ACOUSTICS STUDY

**For
Fayetteville State University**

**By
MHAworks Architects &
Stewart Acoustical Consultants**

Rosenthal Fine Arts Building Acoustics and Sound Transference Study

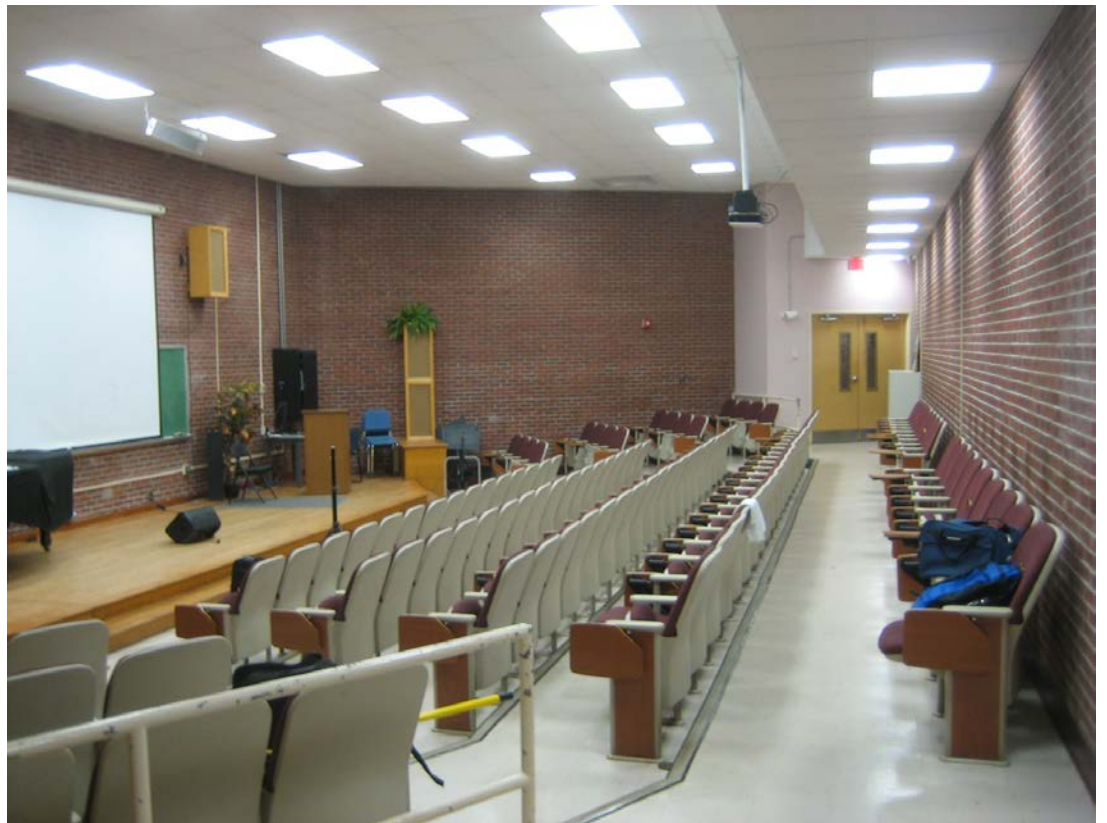
Chorus Room: Maximum room occupancy appears to exceed current industry standards for a room of this volume, floor area per person, and ceiling height.

- b. Limit occupancy - Without any additional effort, the maximum occupancy would have to be reduced to the number that we have recommended in the table (57 for band and 80 for chorus room). Maximum occupancy means something that may occur once a week for a series of weeks, not once a year. One way to limit occupancy is by rehearsing part of the group at a time (with occasional combined sessions held elsewhere.) This is helpful in terms of acoustics as well as safety, especially in the band room where hearing loss is possible due to musicians too close to each other. Tiered seating can mitigate some of the concerns of proximity. Reducing occupancy in the choir room results in a livelier space and can help improve the audibility of the other members of the choir.

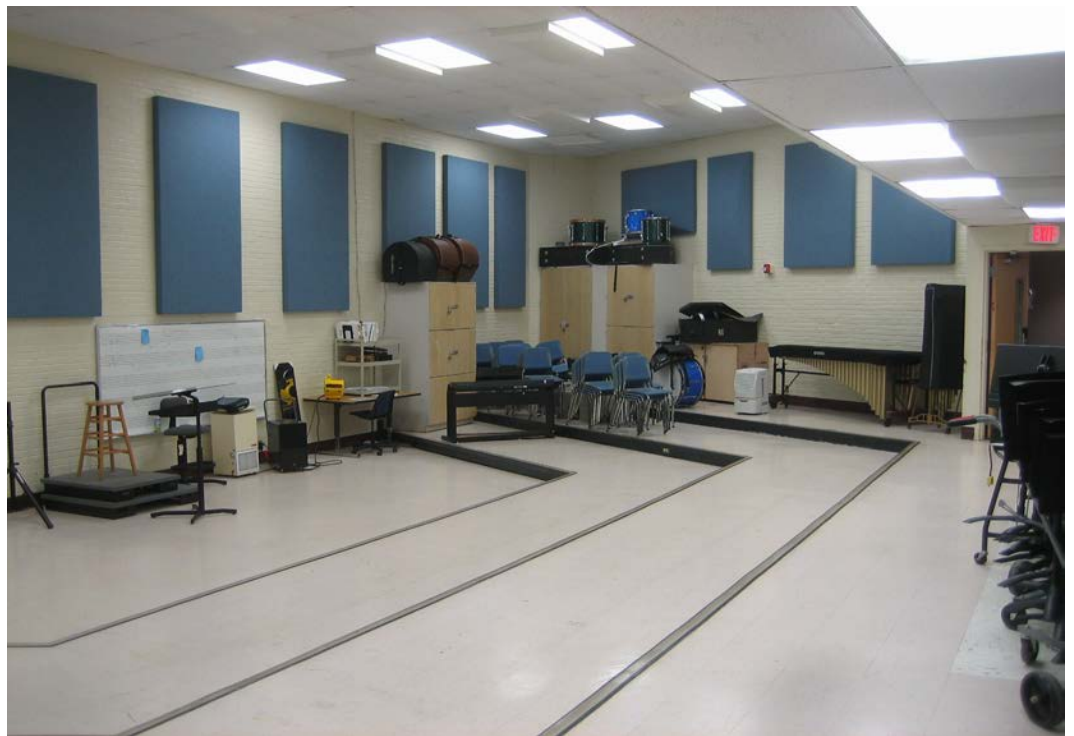
Band Room: Spatial volume, floor area, and ceiling heights are below minimum requirements based on the maximum occupancy of the room.

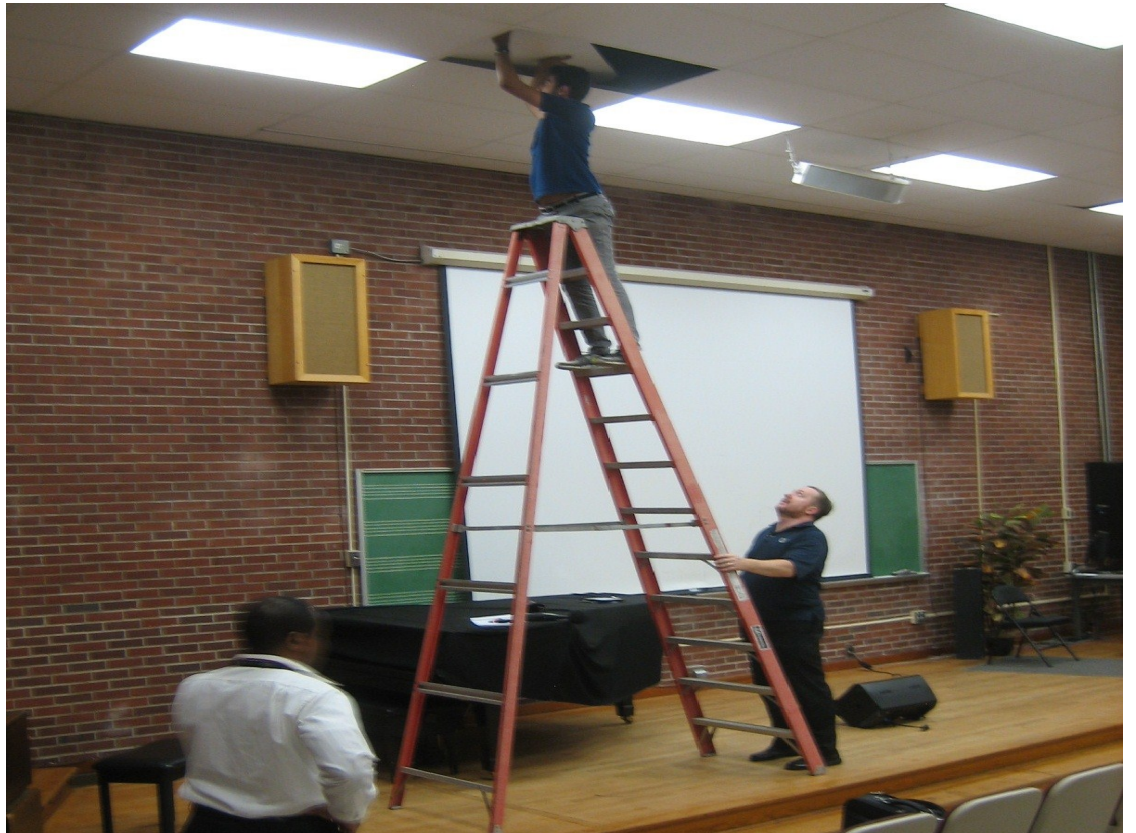
Inspection above ceilings is performed to confirm that room demising walls are sealed above ceilings to create proper room sound isolation.

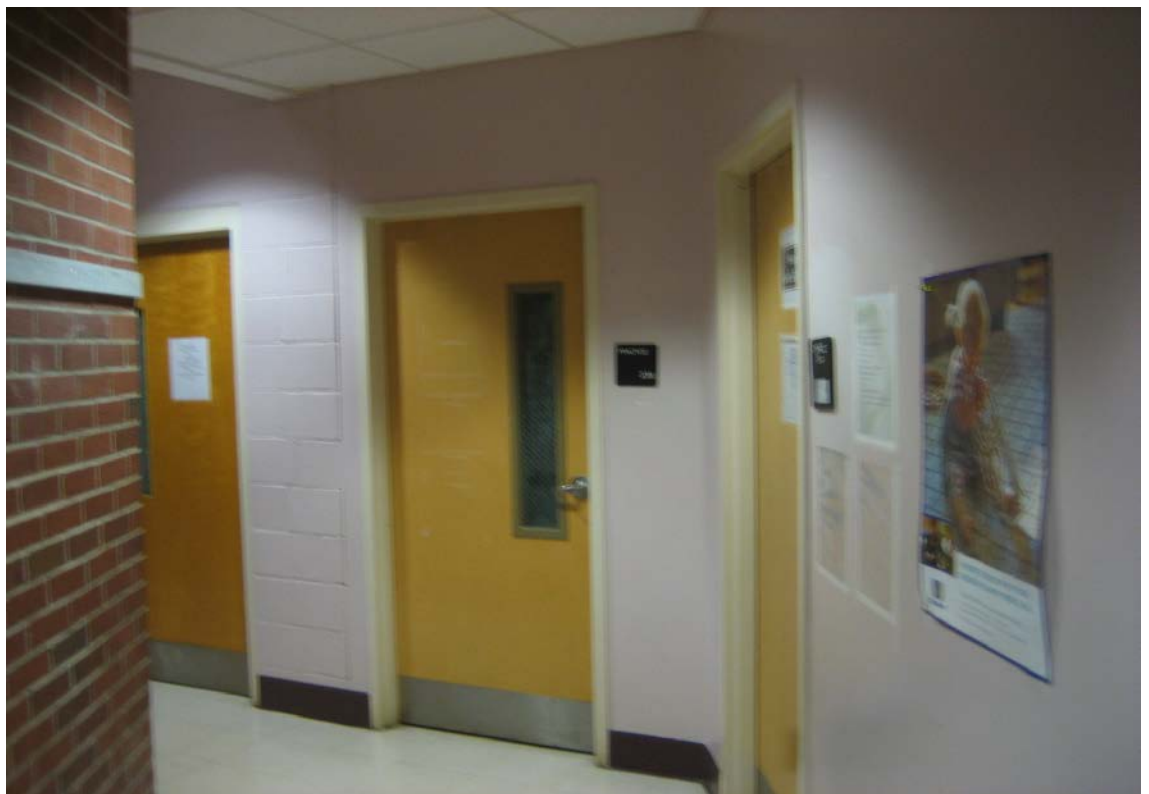
Corridor outside Chorus Room where original practice rooms concrete masonry walls join rooms renovated with gyp. board partitions creating ineffective sound isolation conditions.

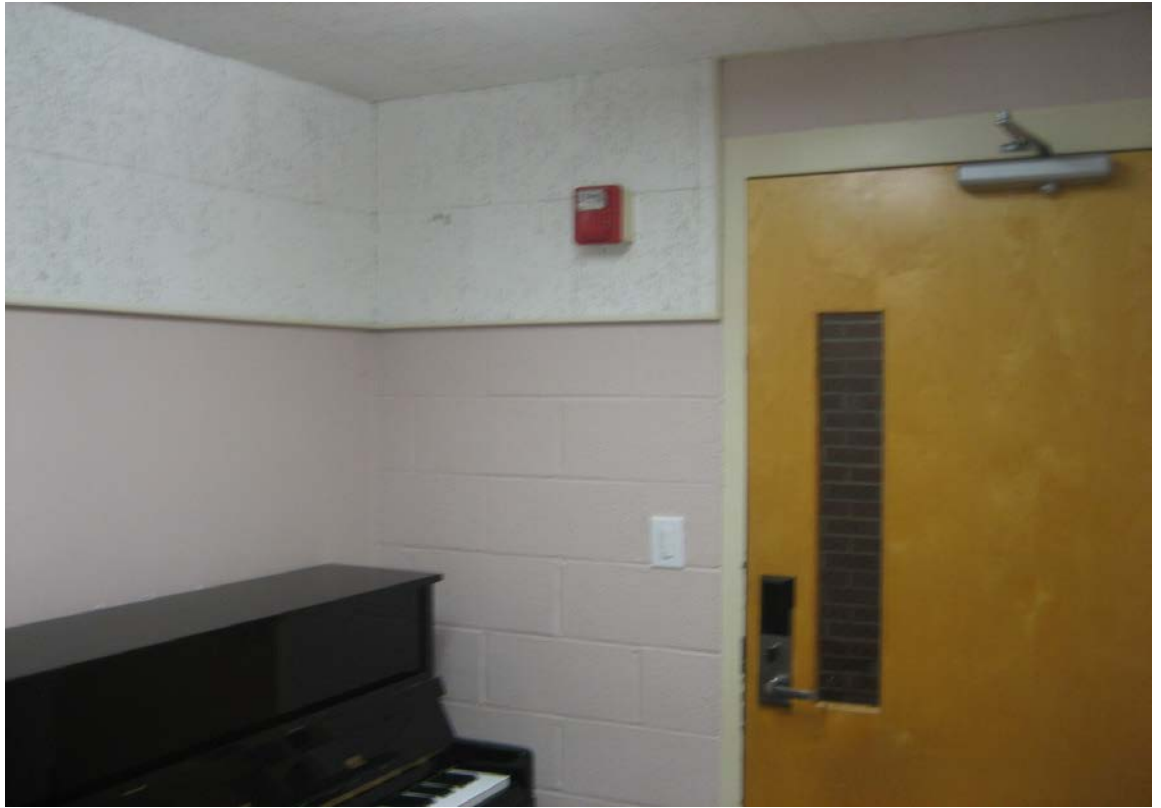
Practice rooms of original 1965 design have masonry corridor walls & acoustic panels adhered to a suspended ceiling. Typical gyp. board wall assembly between rooms has a n STC rating of 56.

2. Practice Rooms – The basic elements are there (cubic volume, floor area, sound absorption at mid-frequencies). However, additional low frequency sound absorption is needed for those spaces without bass traps. We can help determine that in the next phase.
3. In general, if new construction or significant renovation is undertaken – Obviously, if significant renovation is undertaken that requires redoing the finishes of any of the music department spaces, it would be highly recommended that full analysis and recommendations be employed to provide more optimal acoustics for all of these spaces. We focused on priorities to correct deficiencies, not optimizing the acoustics.

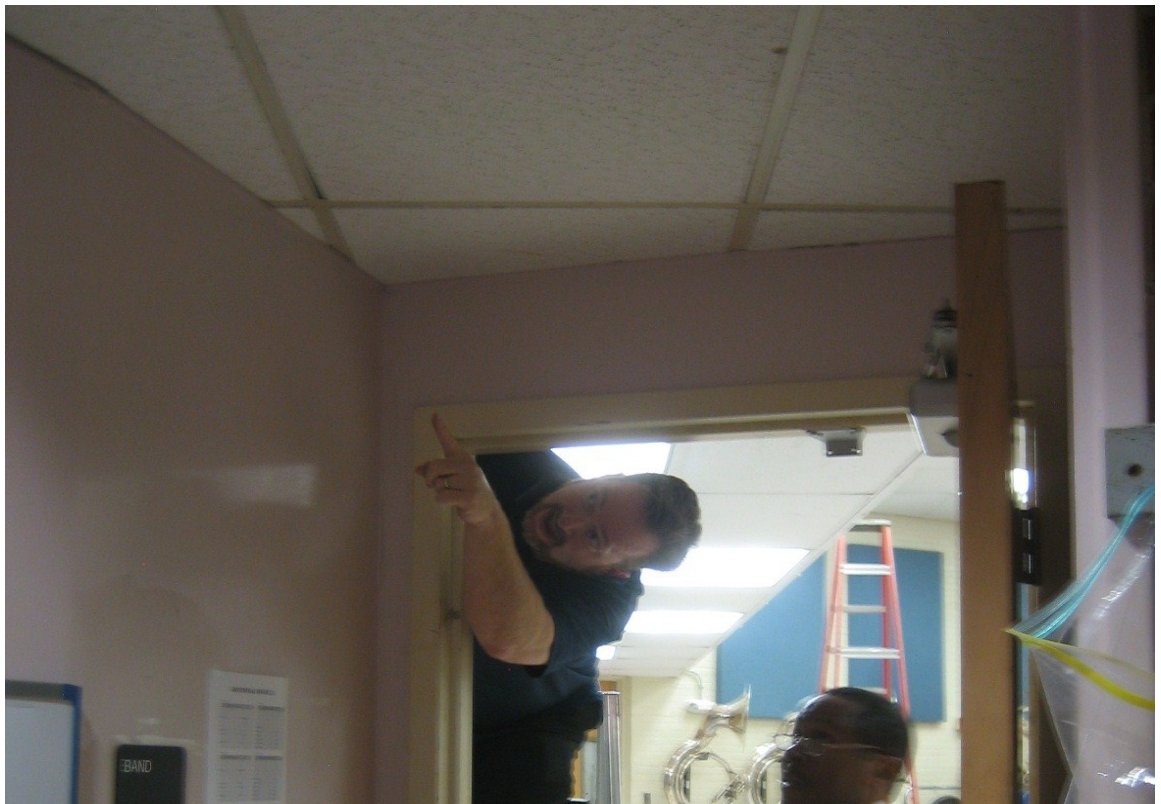
The recessed band room door is not original to the design and the walls above the suspended ceiling are incomplete creating poor sound isolation from the public corridor activities.

- b. Perimeter seals where they exist are in bad shape and need replacement.
 - c. Where perimeter seals were never used, they will need to be added.
2. The entry doors of both the band and choir rooms are recessed into the spaces with walls that stop just above the recessed area ceiling and do not extend to the deck. This should be taken care of. The construction of this vestibule like section is arbitrary as seen in the picture below, and the doors should be pushed out to the hall or existing door walls taken to the deck. The fundamental wall construction between the band room and the chorus does not seem to be the problem and isolation issues should be solved if the problems at the doors are solved.

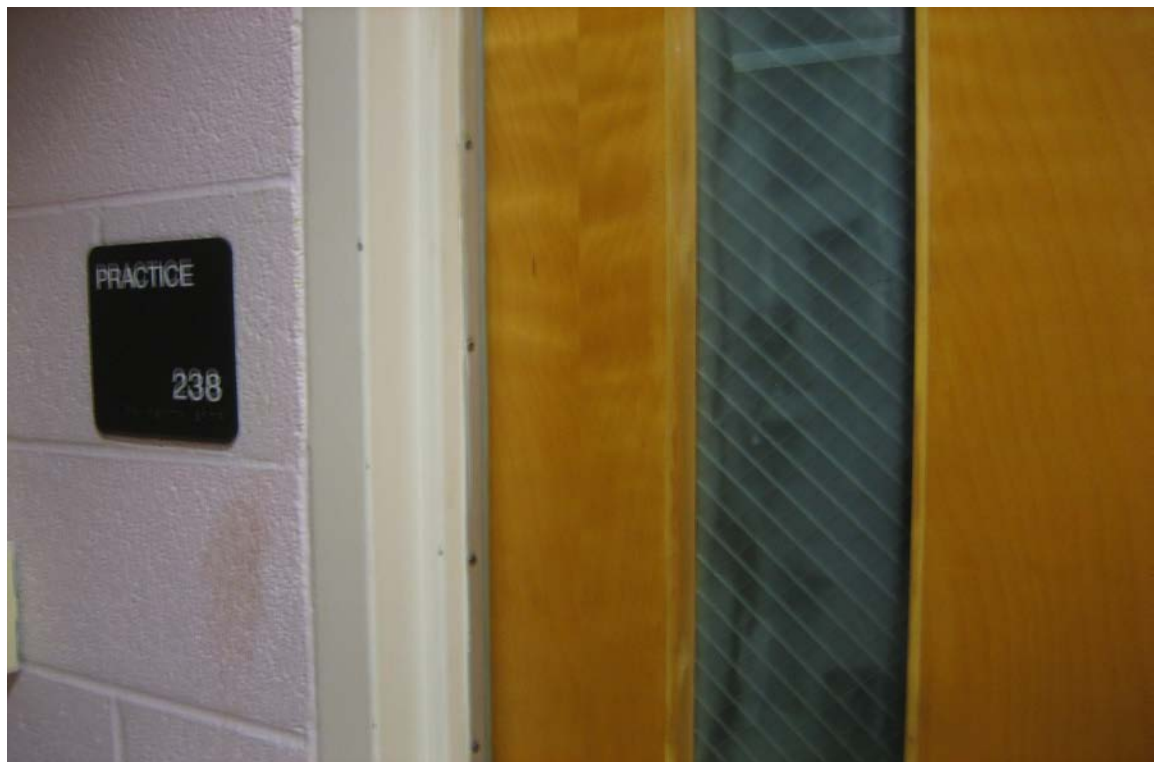
Acoustic door seals are missing or old and poorly functioning. They need to be replaced at all rooms which are used for music performance functions. All doors need drop seals at the sills as well to correct the impact of corridor noise intrusion on the need for practice room privacy.

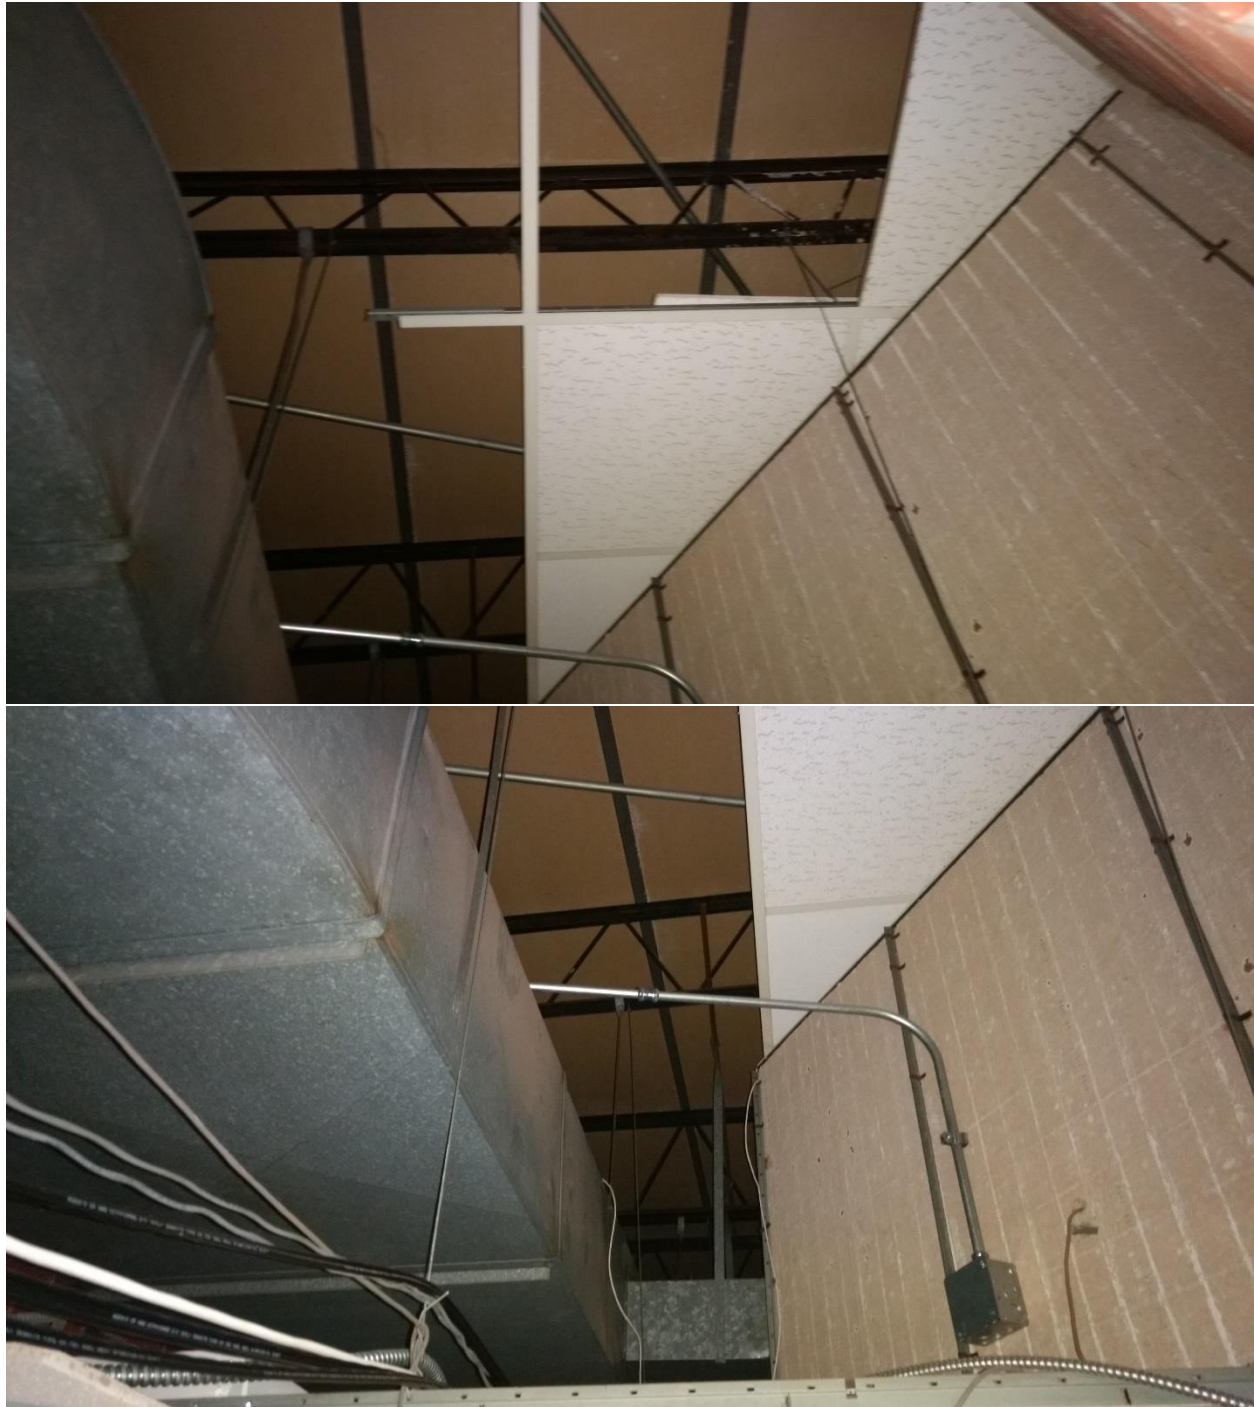
Figure 3: Area above ceiling outside choir room door (lifted acoustical ceiling tile just outside door)

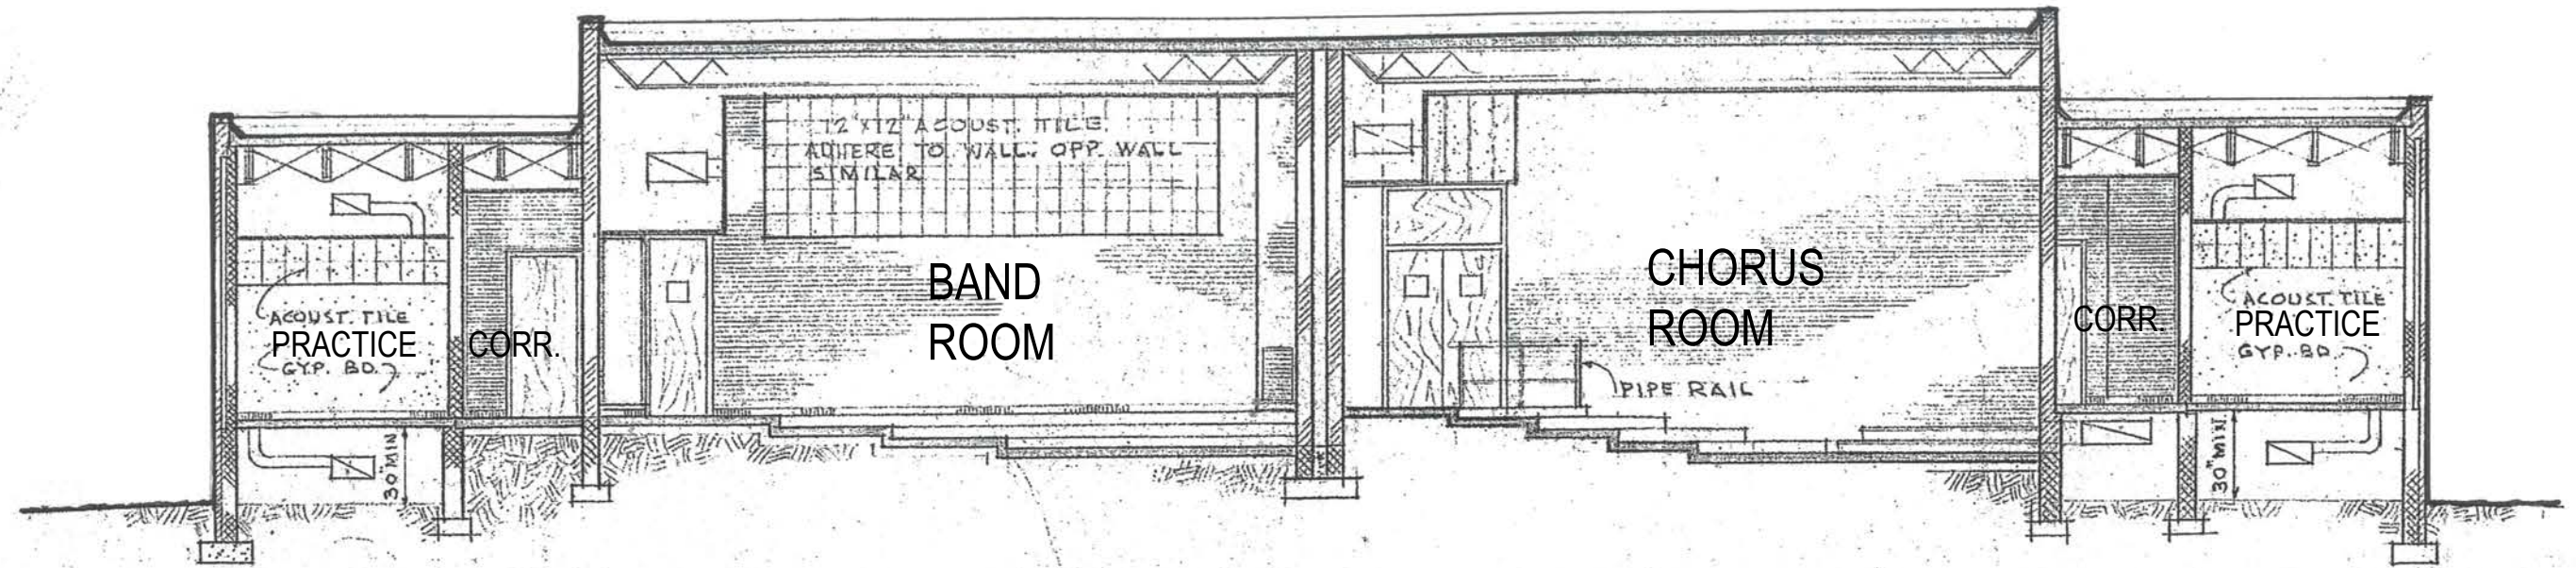
CROSS SECTION "A-A" 1/8" = 1'-0"
 (BAND & CHOIR ROOM WING)

These two large assembly type rooms have masonry perimeter walls that extend above the roof deck. (See building Sections attached) These rooms have some sound dampening panels on their perimeter walls. Room doors from the corridor are not adequately sealed, nor do they have door frame seals or drop seals at the sills. Doors that are pocketed at the south wall of the rooms (part of a later renovation) do not have continuous structure at the door head conditions creating a large sound transmission gap. Refer to the Stewart Acoustical report detailing concerns about room volume and floor area relating to maximum room occupancy.
