ABATEMENT SPECIFICATION

Fayetteville State University Bryant Hall and Vance Hall – Demolition and Abatement

**ABATEMENT BID PACKAGE
Bryant Hall and Vance Hall – Demolition and Abatement
Fayetteville State University
1200 Murchison Road,
Fayetteville, NC 27599**

**SPECIFICATIONS
For
HAZARDOUS MATERIALS ABATEMENT
PRIOR TO THE DEMOLITION
OF
THE BRYANT AND VANCE RESIDECNE HALLS**

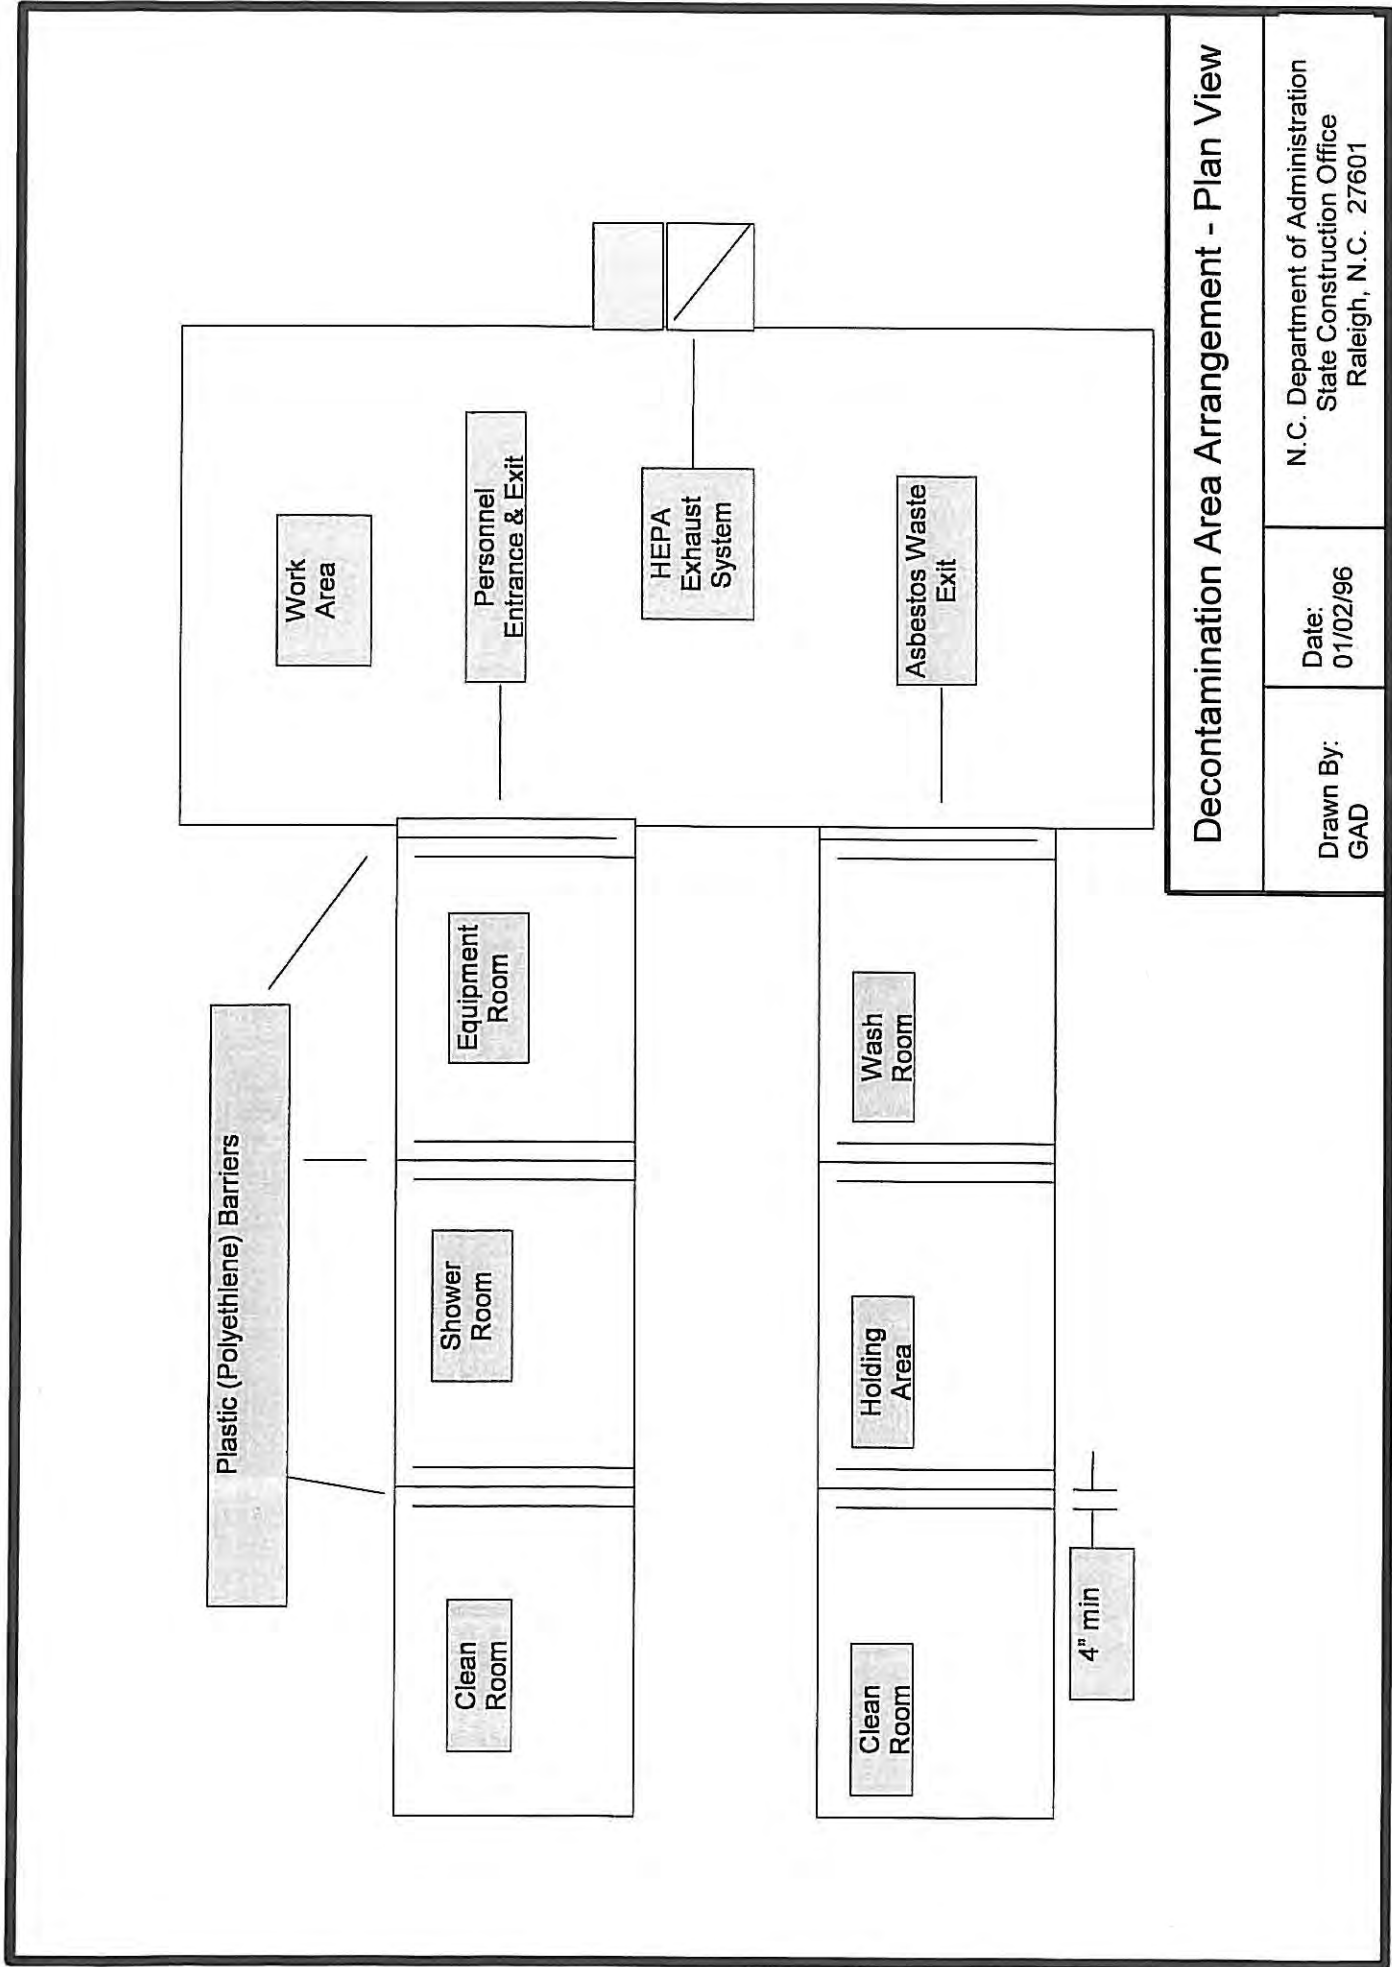
Appendix B

Decontamination Area Arrangement - Plan View

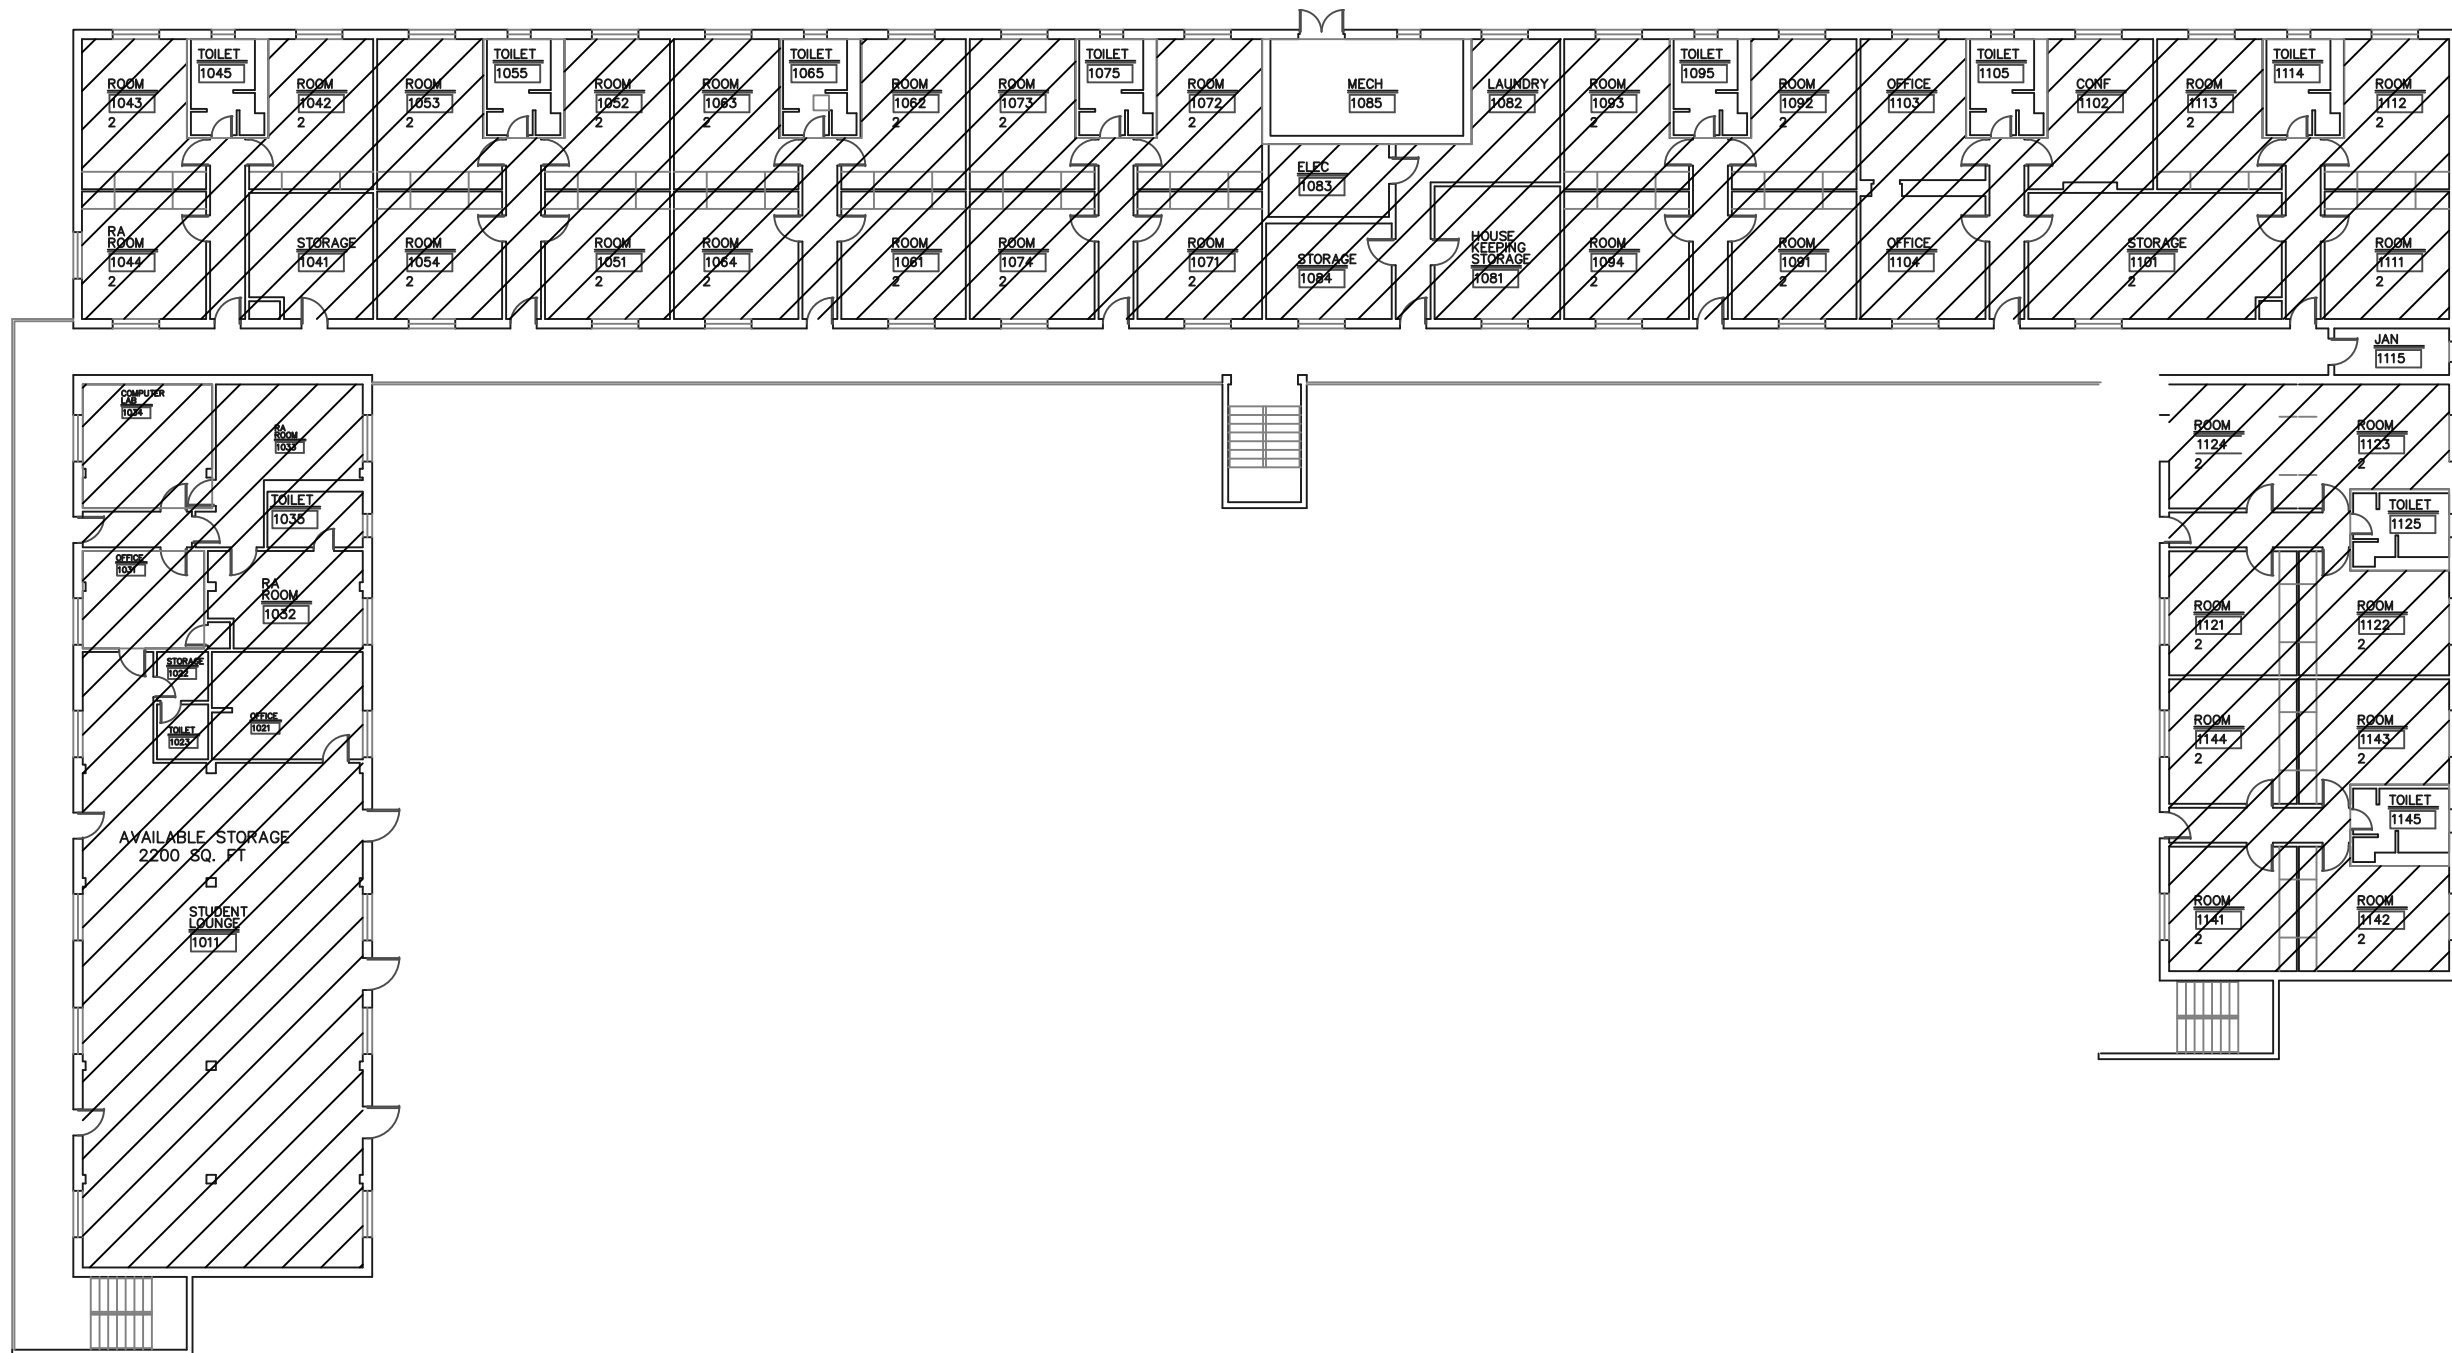
13044-01-01

1. All floor tile and mastic is to be removed.
2. The pipe insulation used on the First Floor is asbestos containing and to be removed. The material is found in the Lounge, above ceilings, and in wall cavities.
3. Two asbestos containing light shields are found in the Suite 104 office. The shields are friable and to be removed.

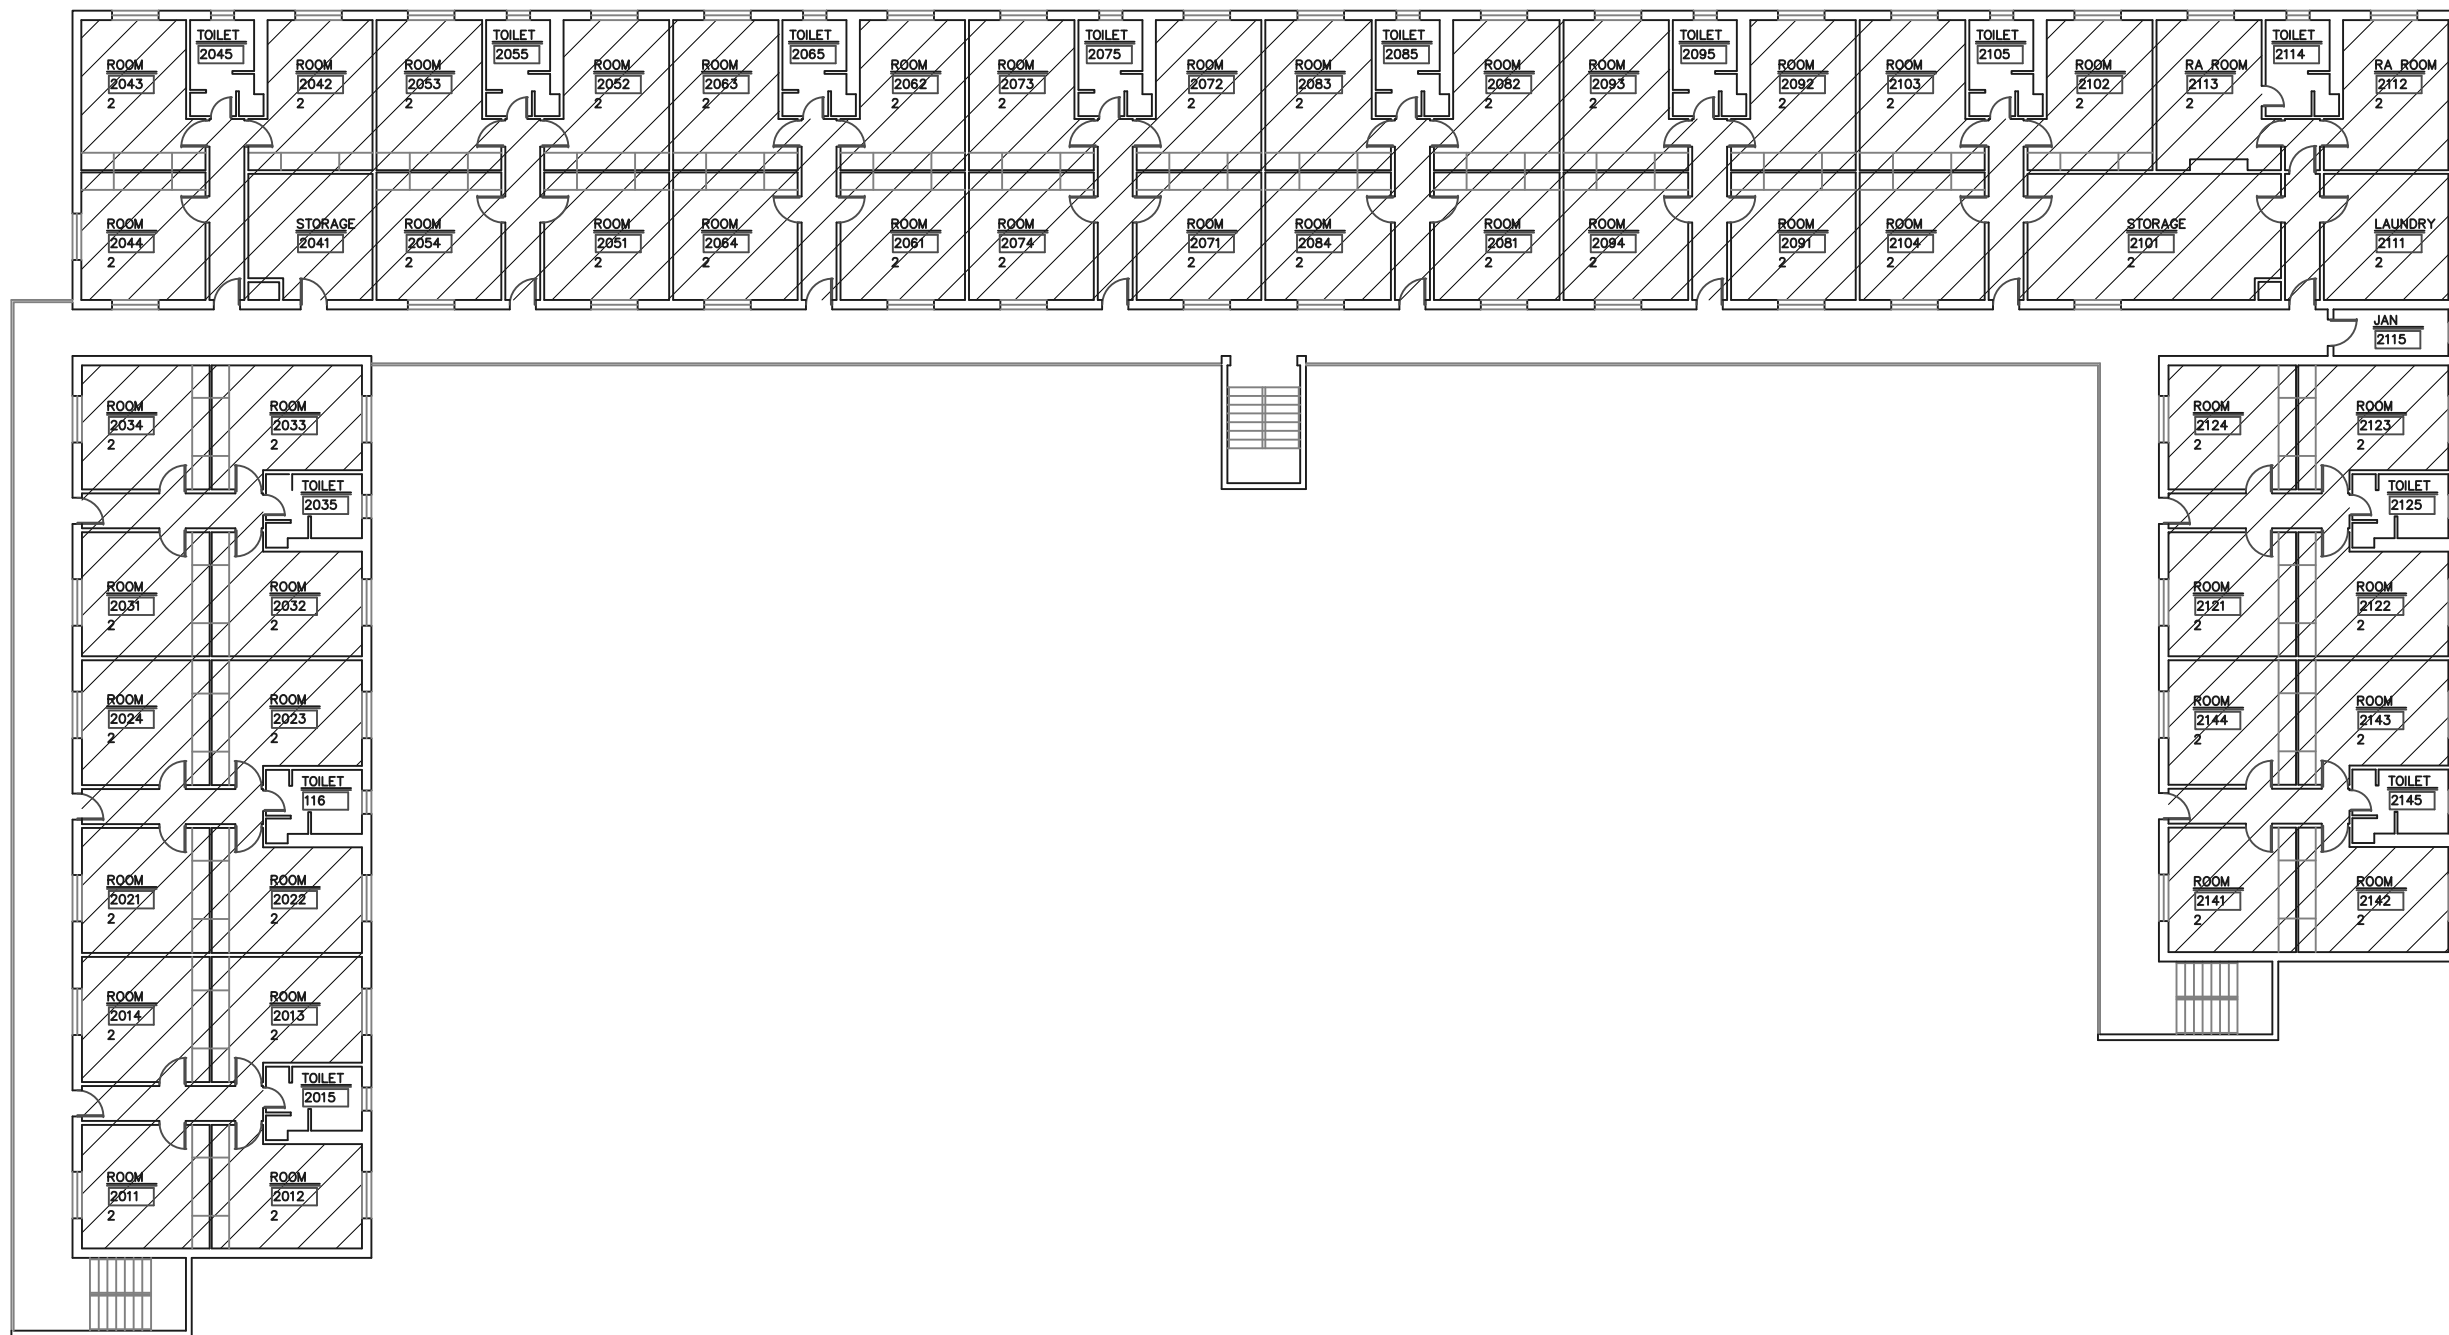
PO Box 2261 Asheville, NC 28802 828-393-8182
Drawn By: DWH	
DATE: 6/24/21	13044-02-01

1. All floor tile and mastic is to be removed.
2. The pipe insulation used on the First Floor is asbestos containing and to be removed. If any of the same material is found on other floors in areas such as wall cavities, the material is also to be removed.

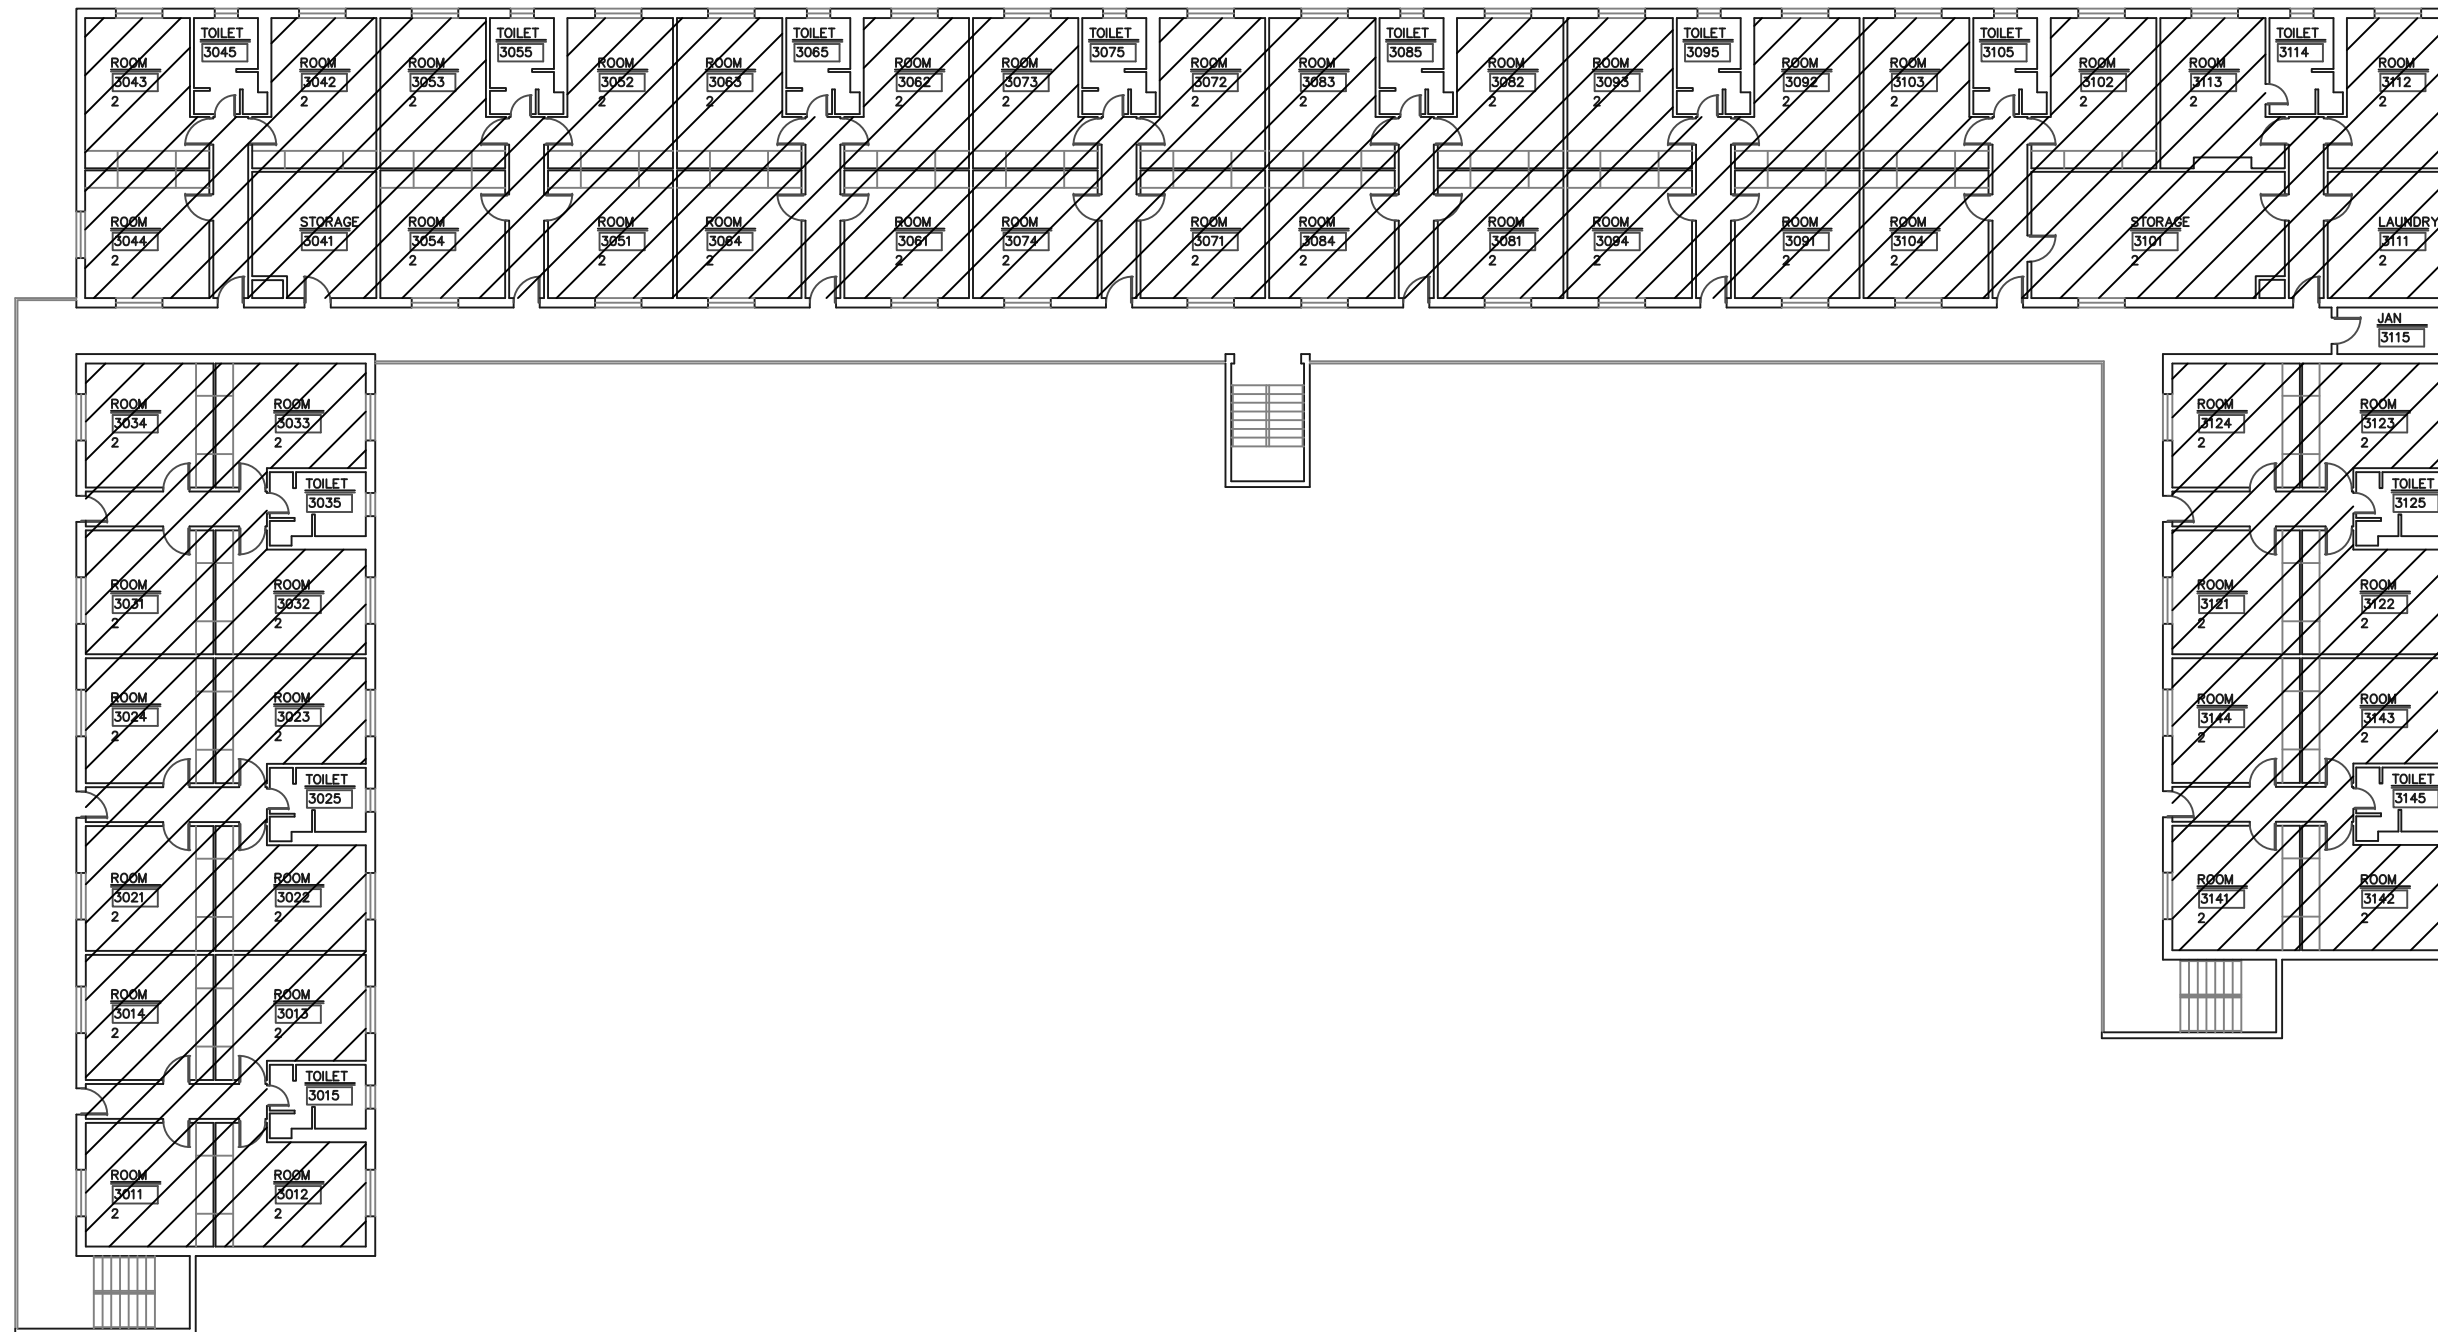
Energy & Environmental Engineers, PA PO Box 2261 Asheville, NC 28802 828-393-8182
Drawn By: DWH	
DATE: 6/24/21	13044-03-01

1. All floor tile and mastic is to be removed.
2. The pipe insulation used on the First Floor is asbestos containing and to be removed. If any of the same material is found on other floors in areas such as wall cavities, the material is also to be removed.

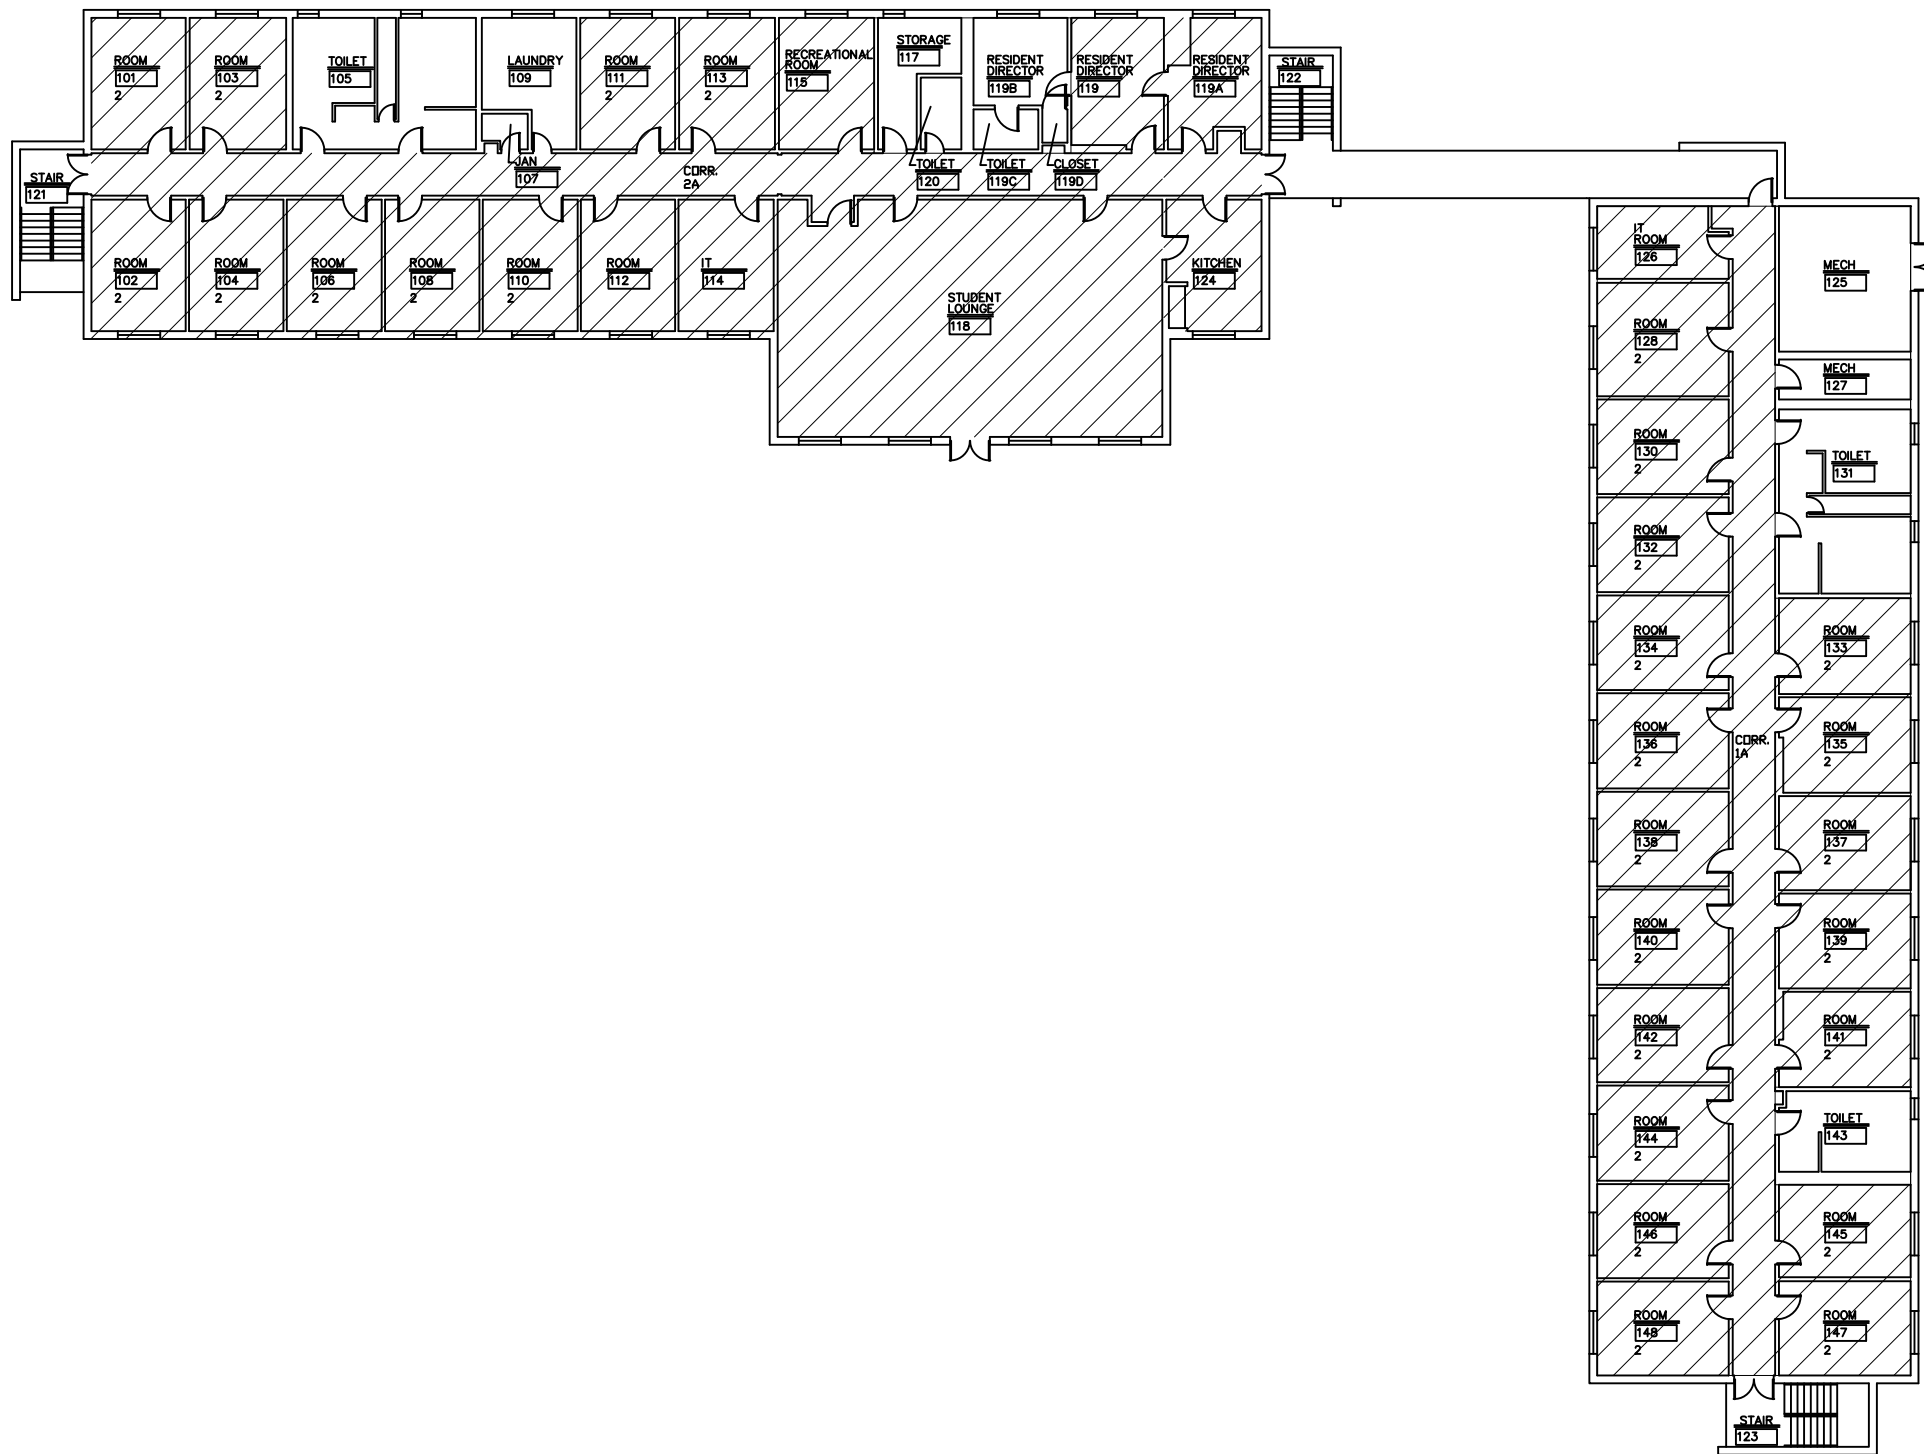
13044-04-01

1. All floor tile and mastic is to be removed.
2. The caulking around all exterior doors is asbestos containing and to be removed.

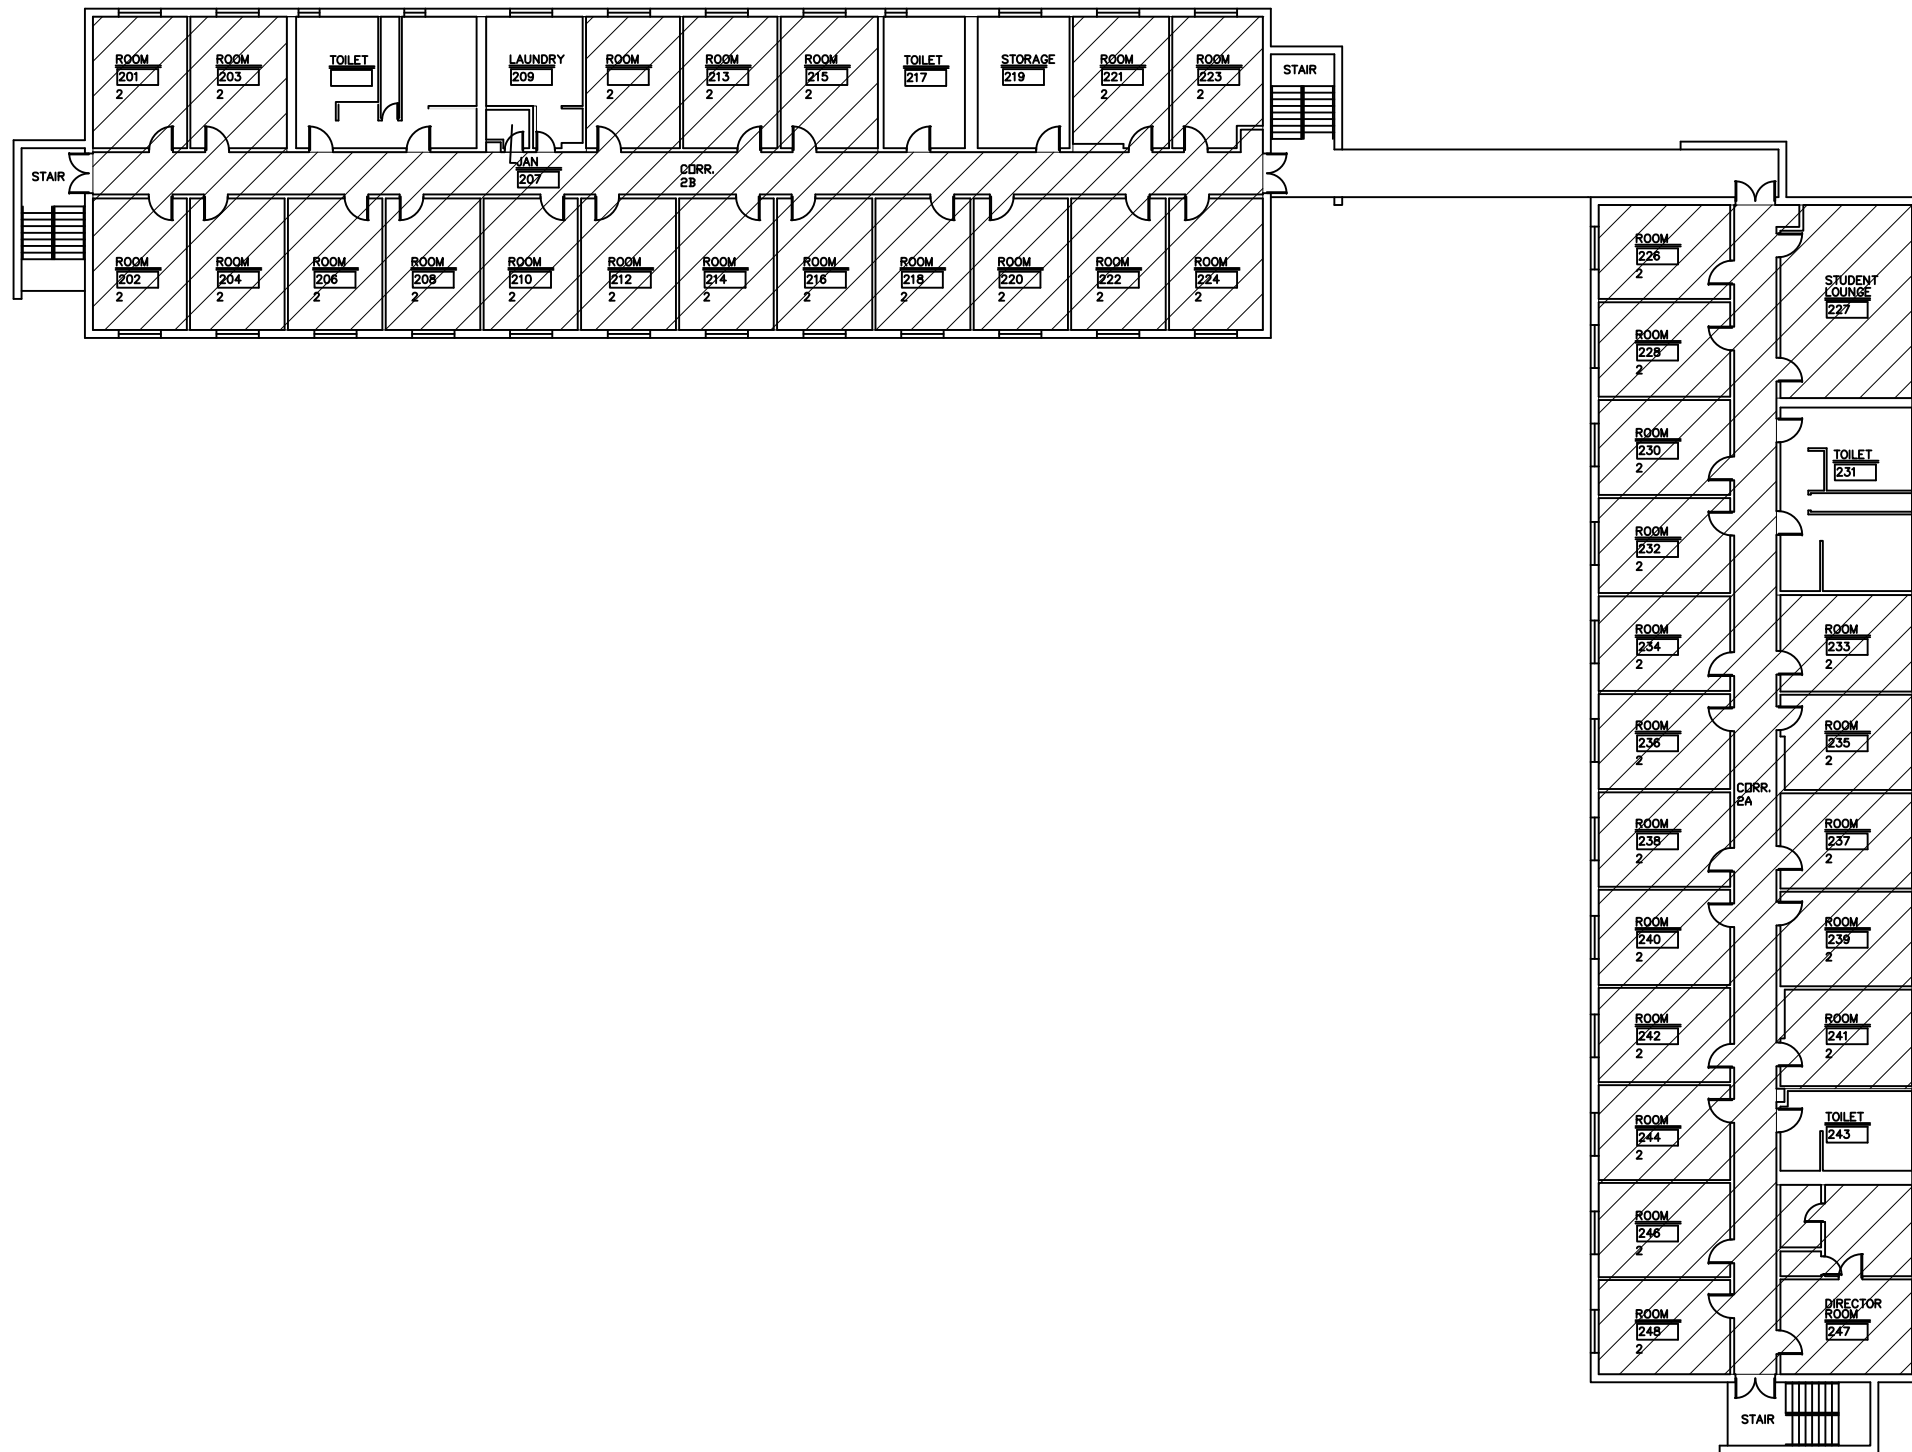
PO Box 2261 Asheville, NC 28802 828-393-8182
Drawn By: DWH	
DATE: 6/24/21	13044-05-01

1. All floor tile and mastic is to be removed.
2. The caulking around all exterior doors is asbestos containing and to be removed.

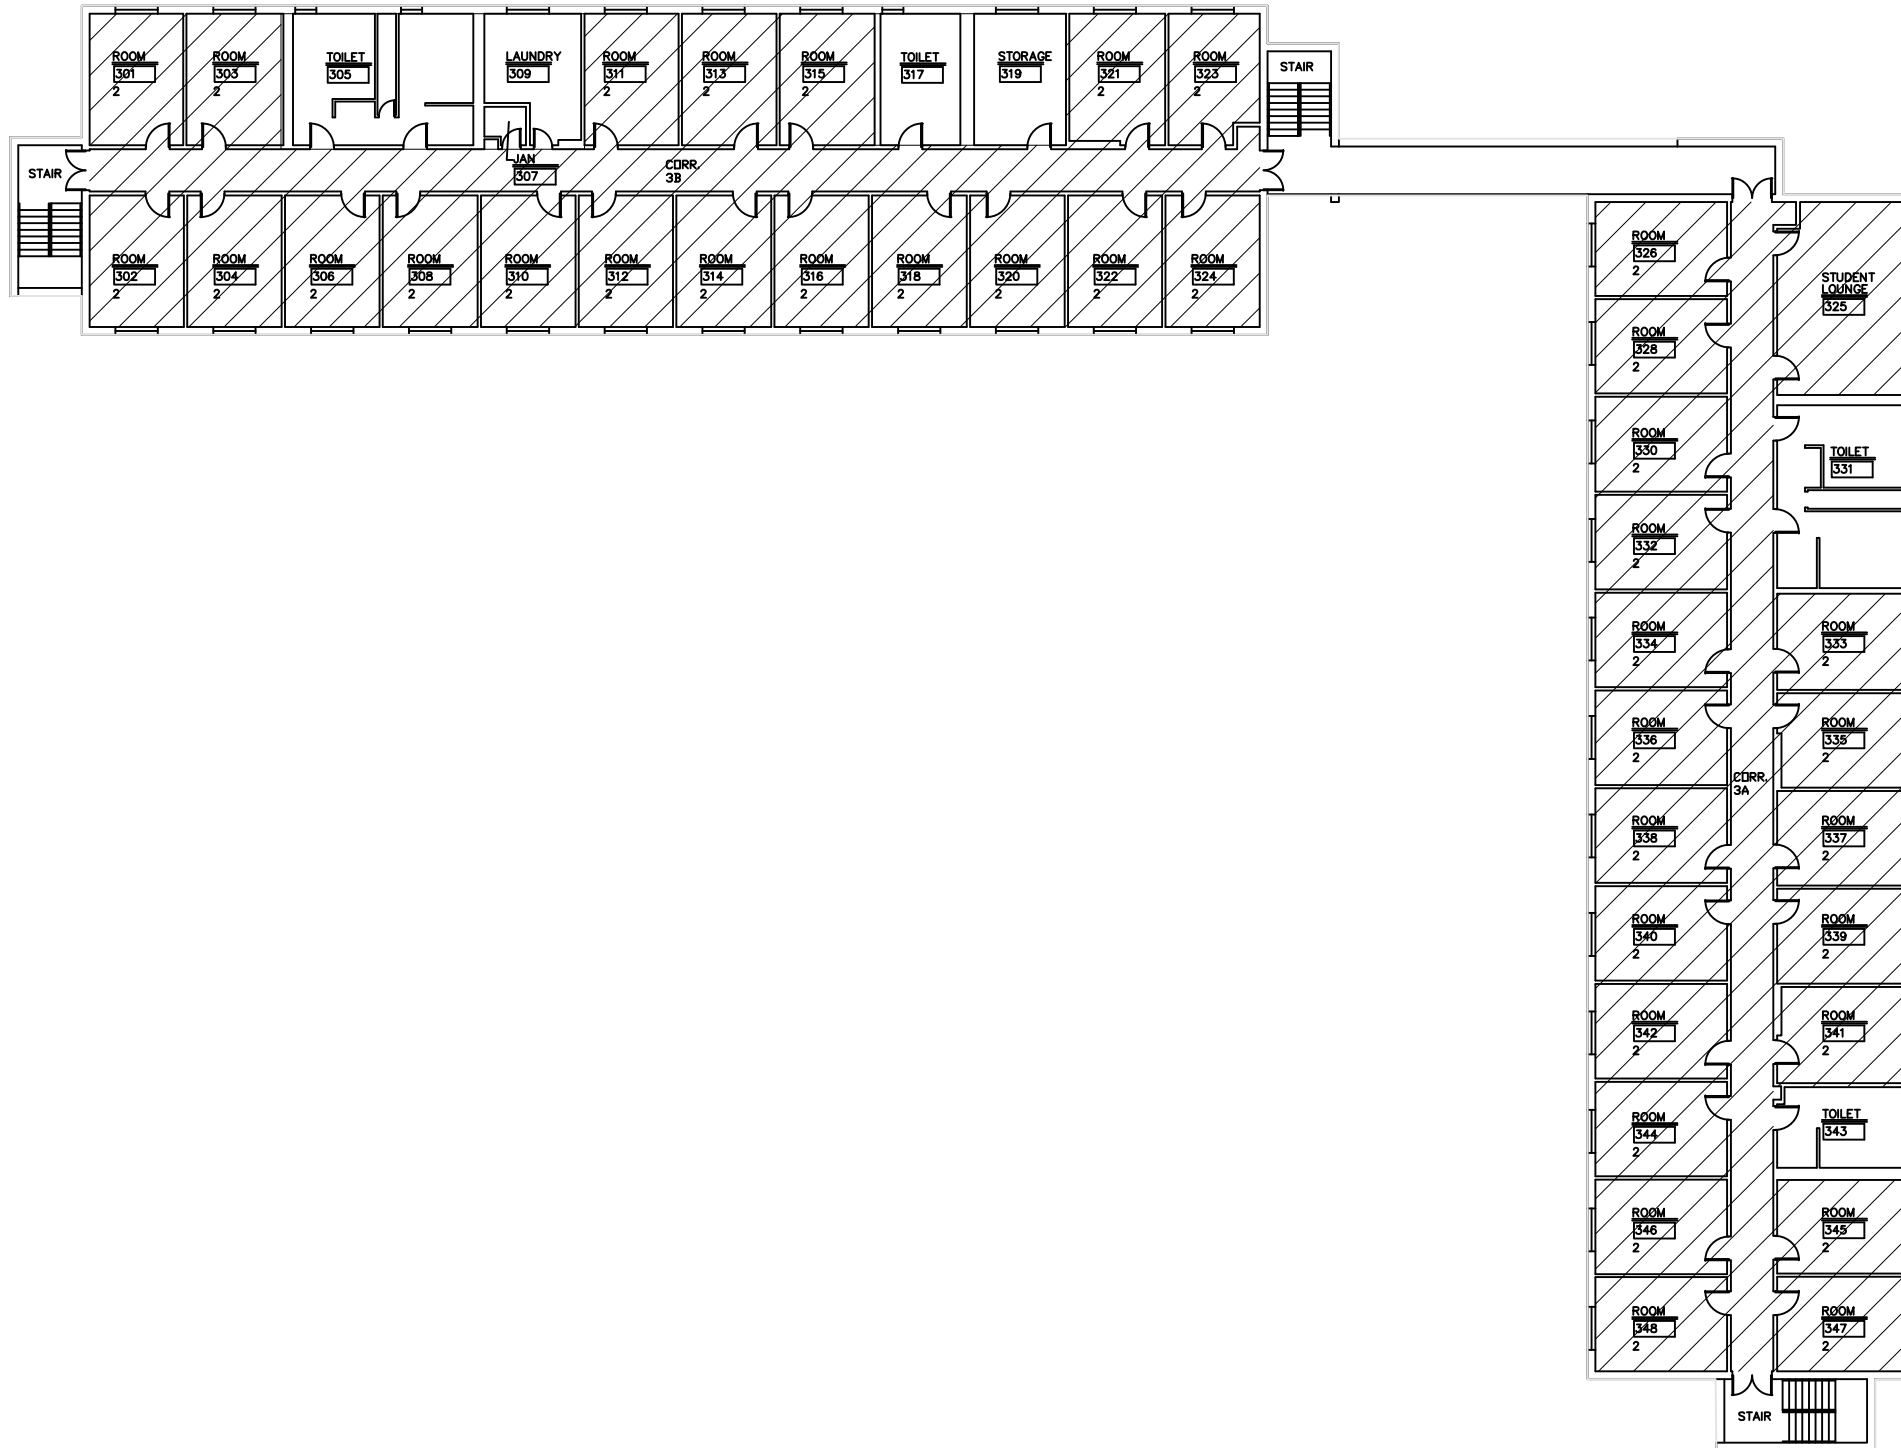
1. All floor tile and mastic is to be removed.
2. The caulking around all exterior doors is asbestos containing and to be removed.
