ABATEMENT SPECIFICATION

Fayetteville State University Bryant Hall and Vance Hall – Demolition and Abatement

**ABATEMENT BID PACKAGE
Bryant Hall and Vance Hall – Demolition and Abatement
Fayetteville State University
1200 Murchison Road,
Fayetteville, NC 27599**

**SPECIFICATIONS
For
HAZARDOUS MATERIALS ABATEMENT
PRIOR TO THE DEMOLITION
OF
THE BRYANT AND VANCE RESIDECNE HALLS**

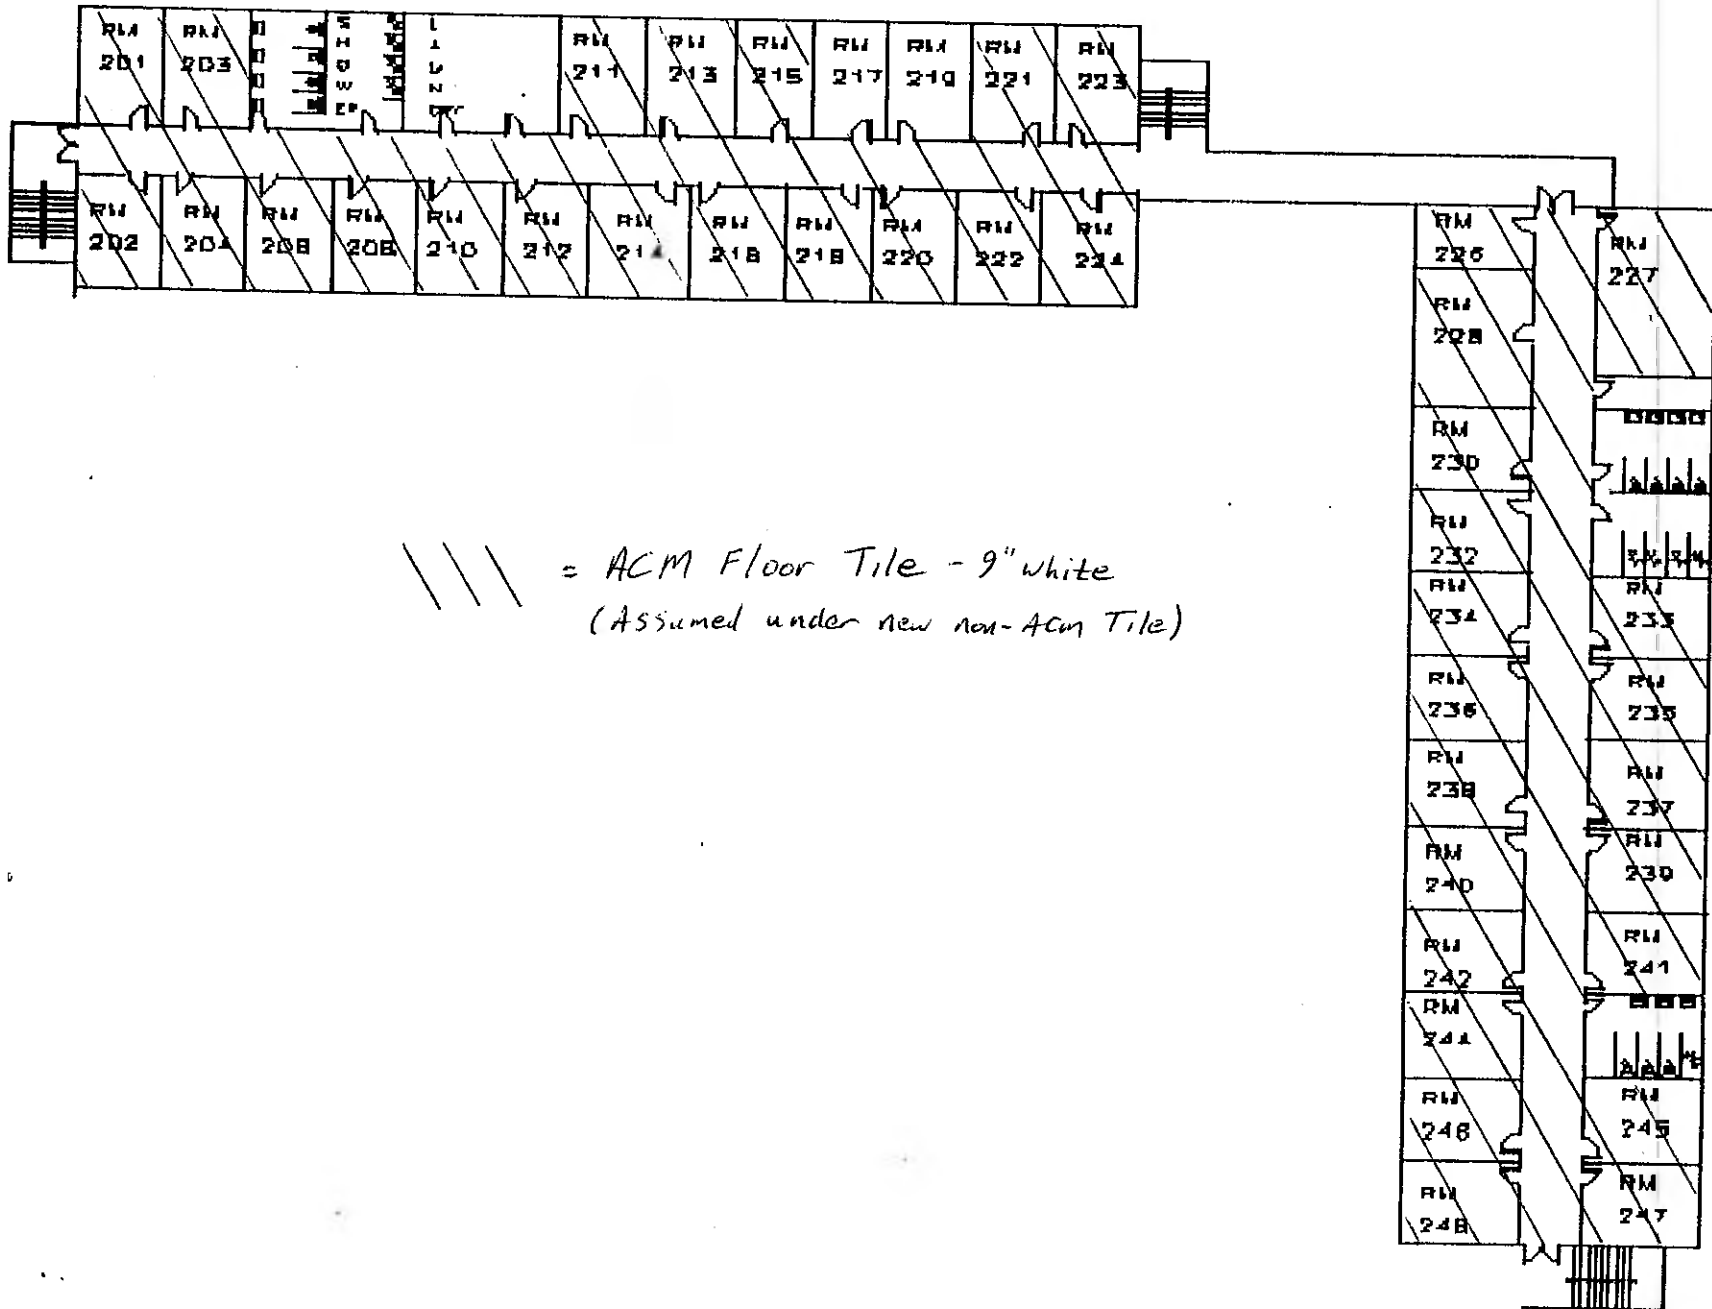
Homogeneous Area Map
Bryant Hall
2nd Floor

/// = ACM Floor Tile - 9" white
 (Assumed under new non-ACM Tile)

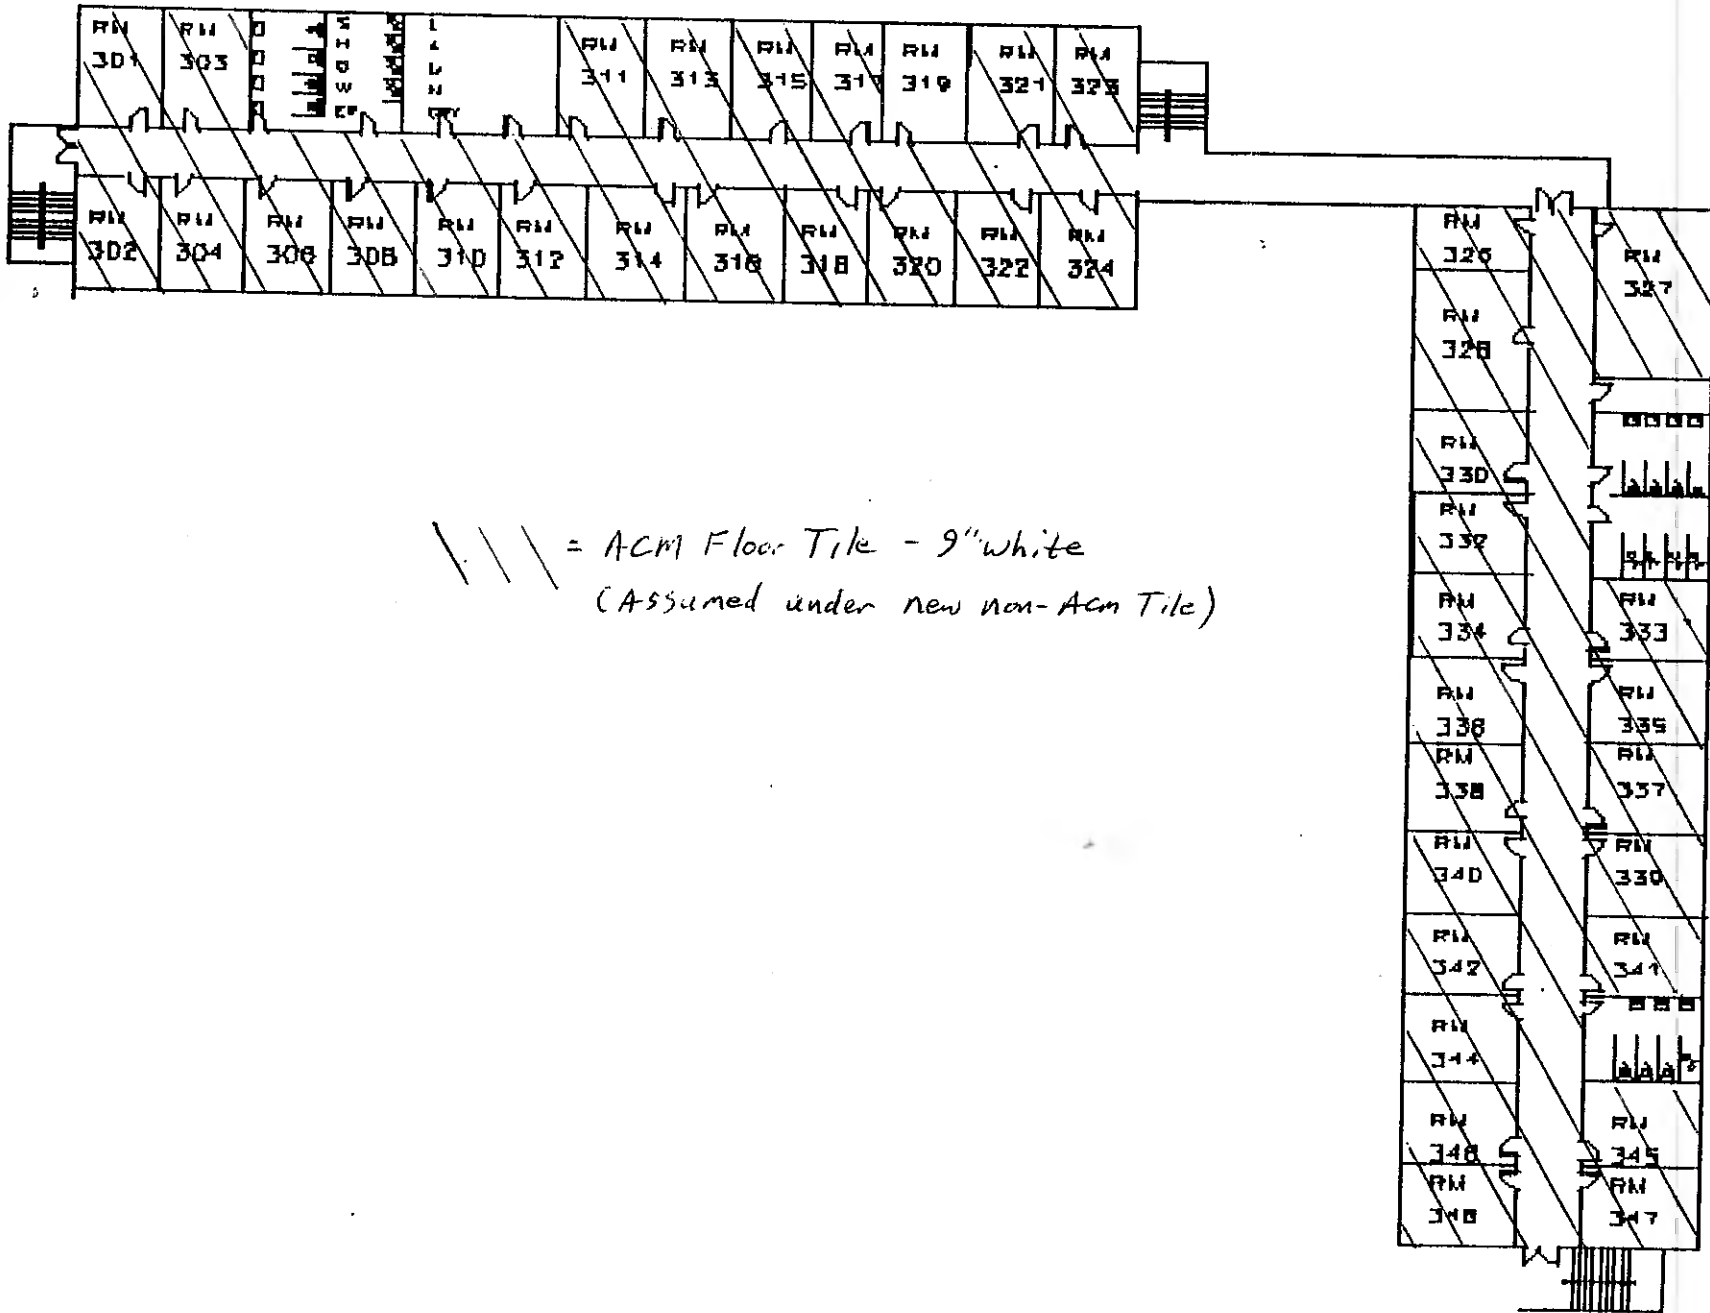
Homogeneous Area Map

/// = ACM Floor Tile - 9" white
(Assumed under new non-ACM Tile)

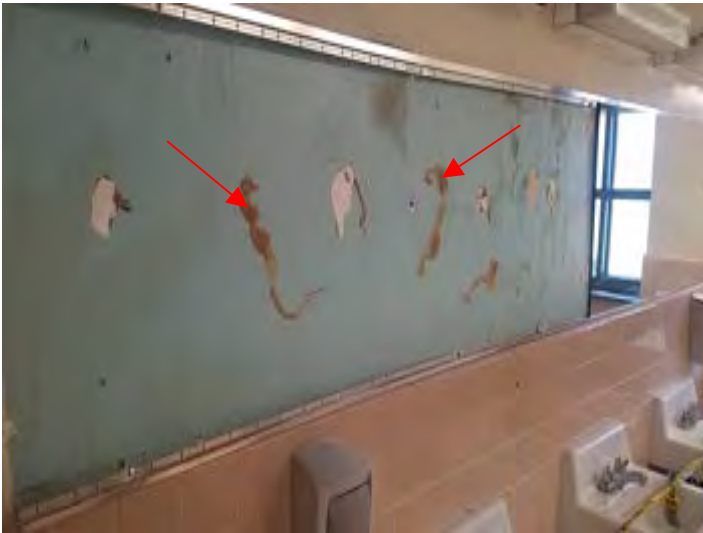
PHOTO No. 1

Typical View In Bryant Hall Negative Brown Glue Adhesive In Restrooms

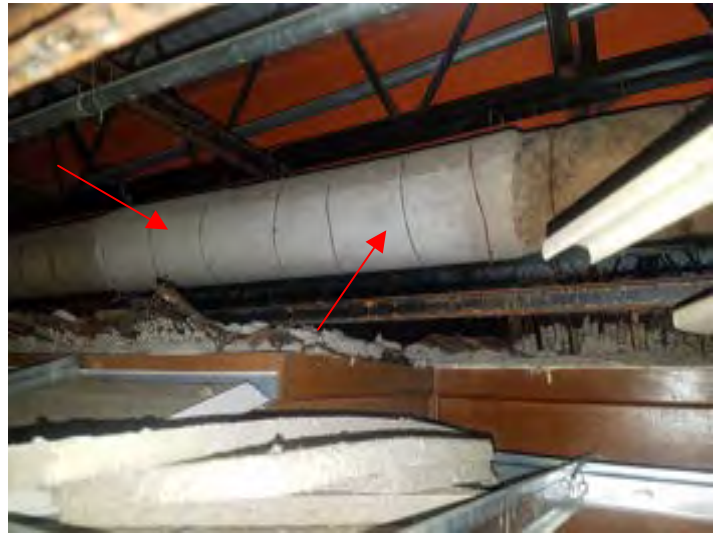
PHOTO No. 2

Typical View In Vance Hall First Floor Positive Thermal System Insulation (TSI) That Remains On Fiberglass Pipeline. Located In Various Locations on First Floor

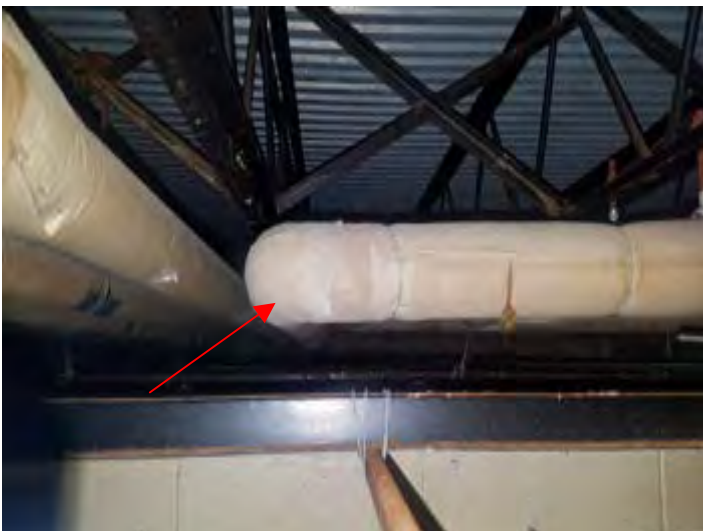
PHOTO No. 3

Typical View In Vance Hall First Floor of Positive TSI Elbows That Remains On Fiberglass Pipeline. Located In Various Locations on First Floor

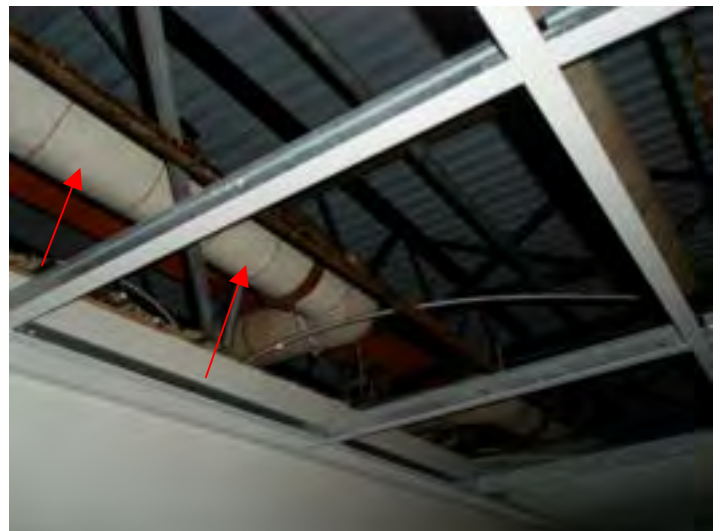
PHOTO No. 4

Another View In Vance Hall First Floor of Positive TSI That Remains On Fiberglass Pipeline In Various Locations on First Floor

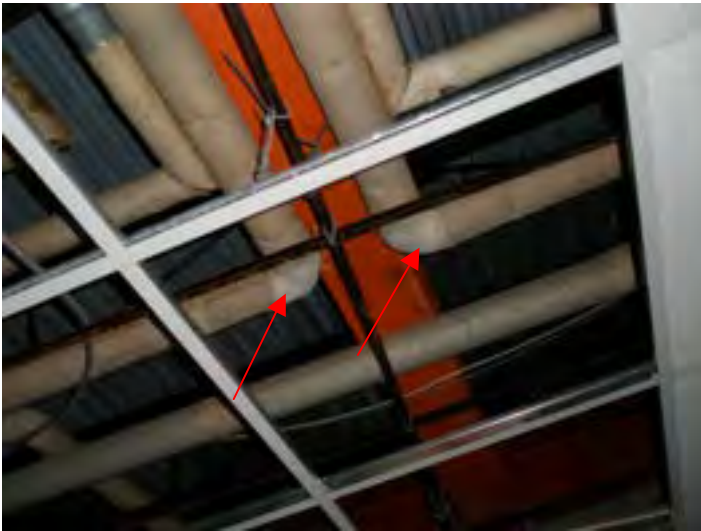
PHOTO No. 5

Another View In Vance Hall First Floor of Positive TSI Elbows That Remains On Fiberglass Pipelines Located In Various Locations on First Floor

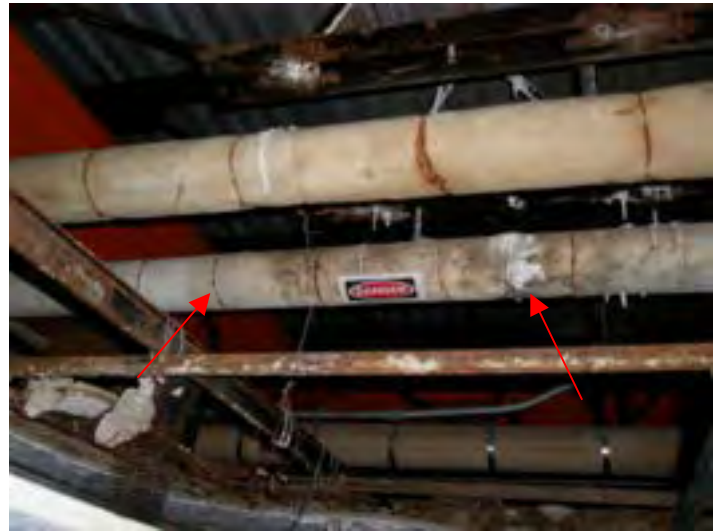
PHOTO No. 6

Another View In Vance Hall First Floor of Positive Identified TSI Pipeline Located In Various Locations on First Floor

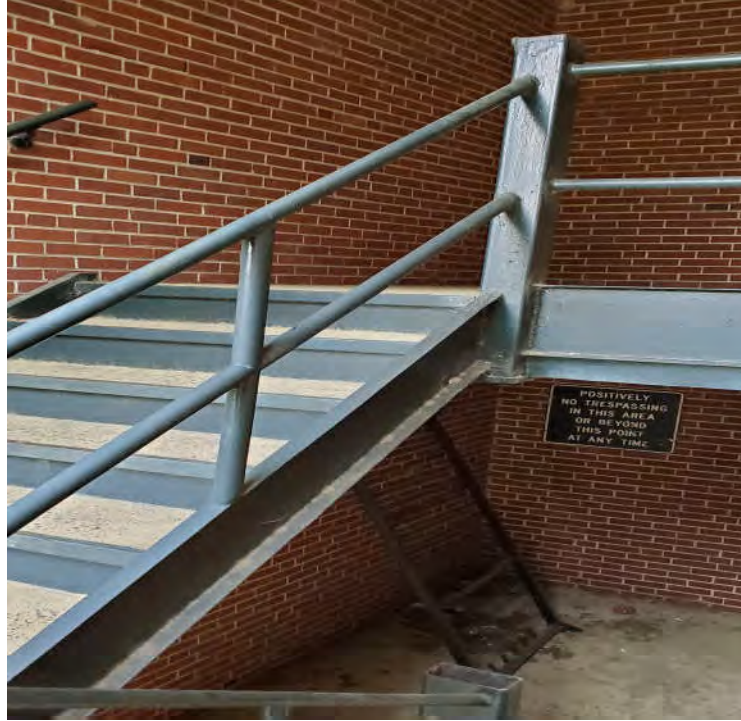
Photograph 1 - Typical Lead-Based Paint on Stair Components (Railings, Risers, Stringers, etc.) of Bryant Hall.

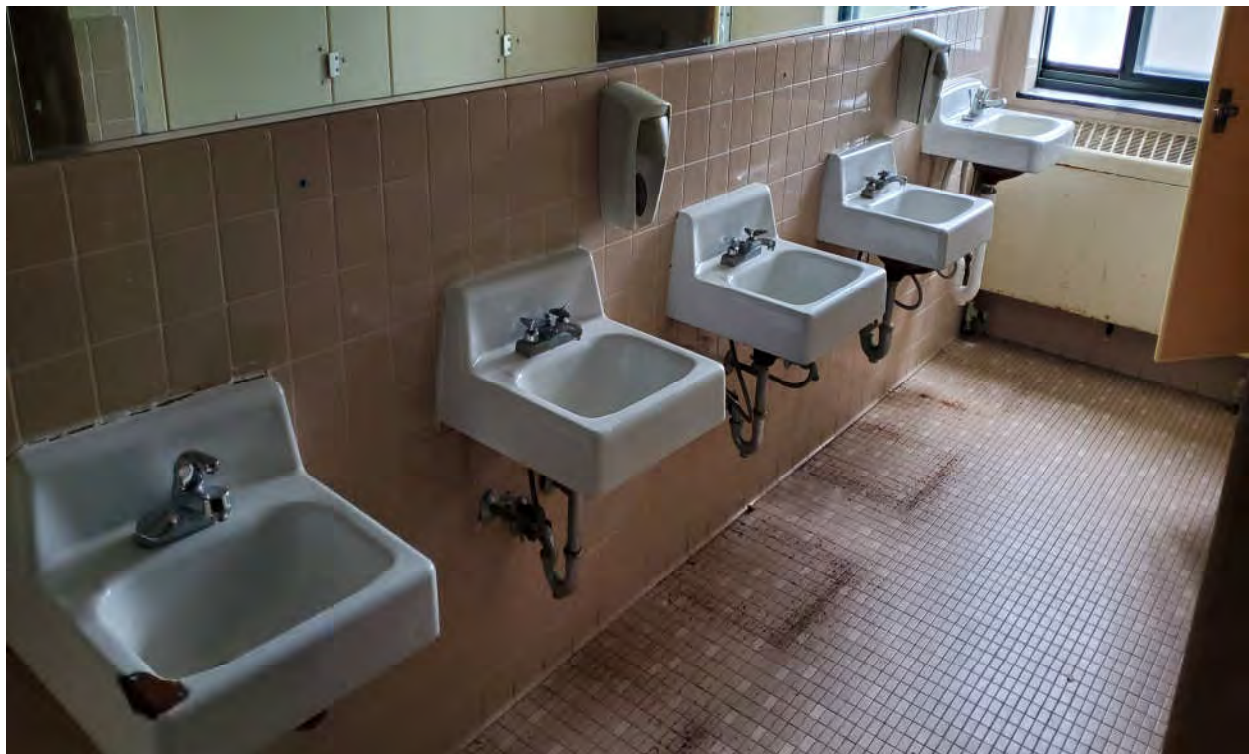
Photograph 2 - Typical Lead-Containing Coating on Porcelain Sinks Located Throughout Bryant Hall.

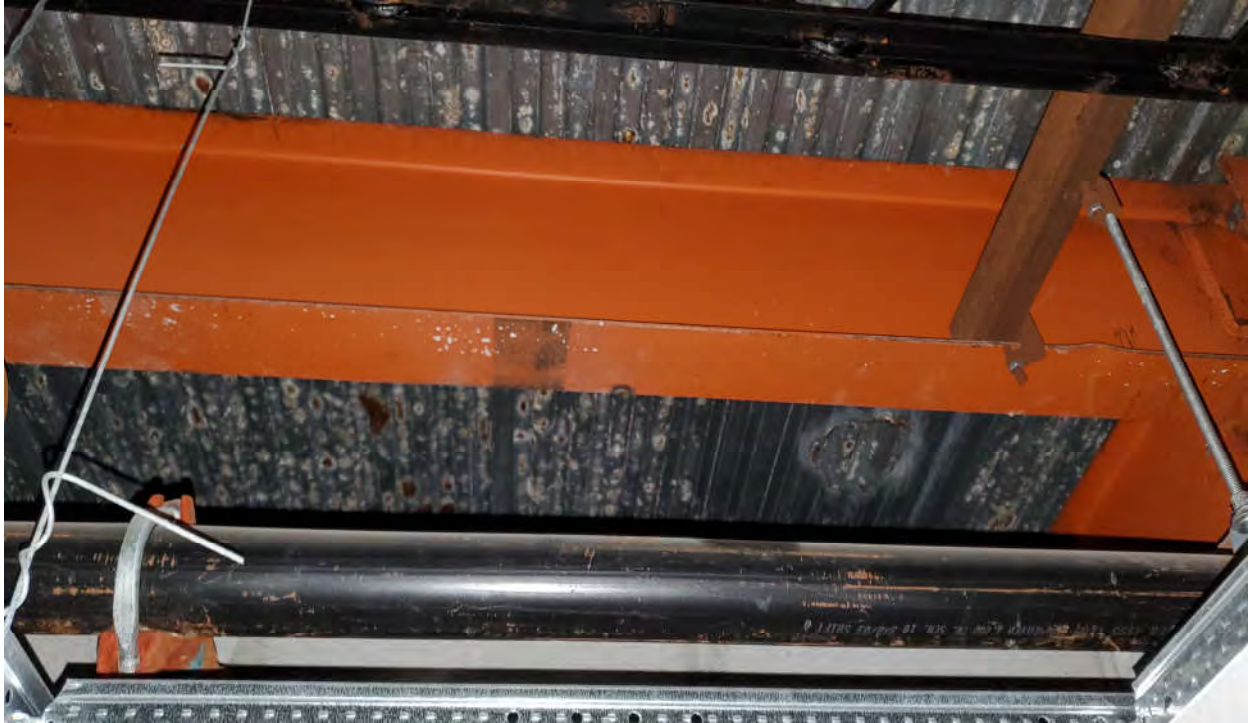
Photograph 3 - Typical Lead-Based Paint on Metal I-Beams Located Throughout Bryant Hall.

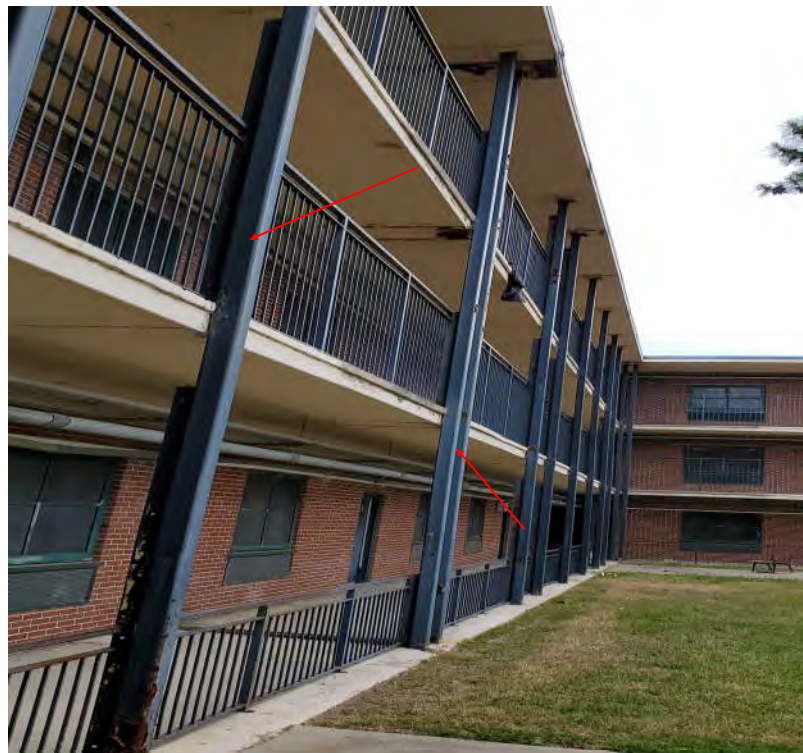
Photograph 4 - Typical Lead-Based Painted Support Columns Located Throughout the Exterior of Vance Hall.

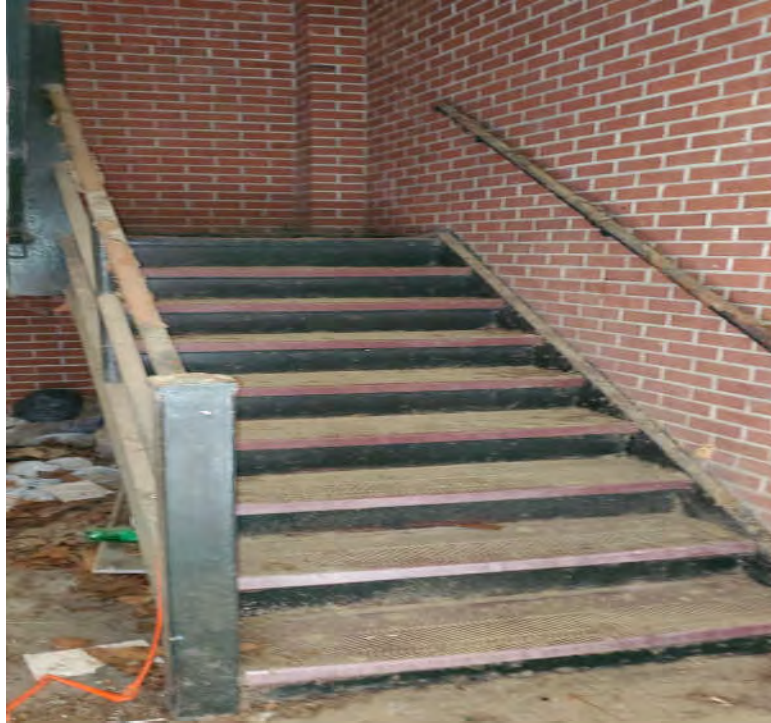
Photograph 5 - Typical Lead-Based Paint on Stair Components (Railings, Risers, Stringers, etc.) of Vance Hall.

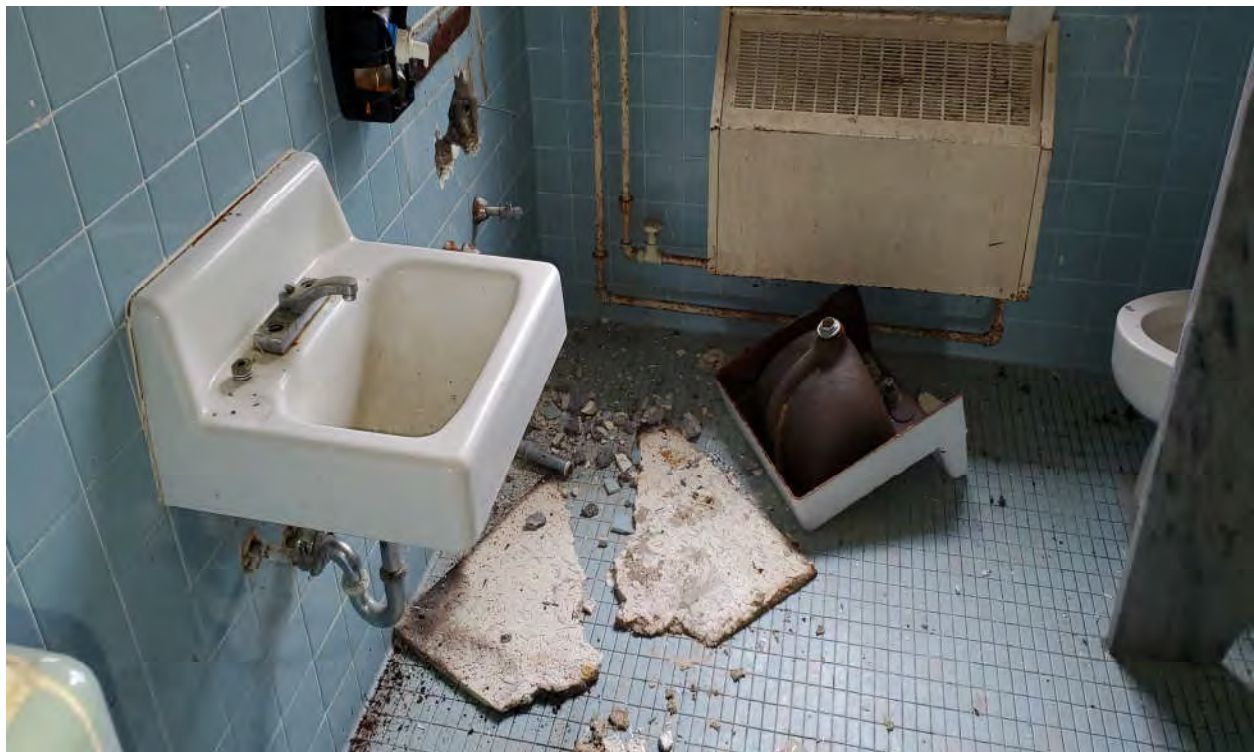
Photograph 6 - Typical Lead-Containing Coating on Porcelain Sinks Located Throughout Vance Hall.

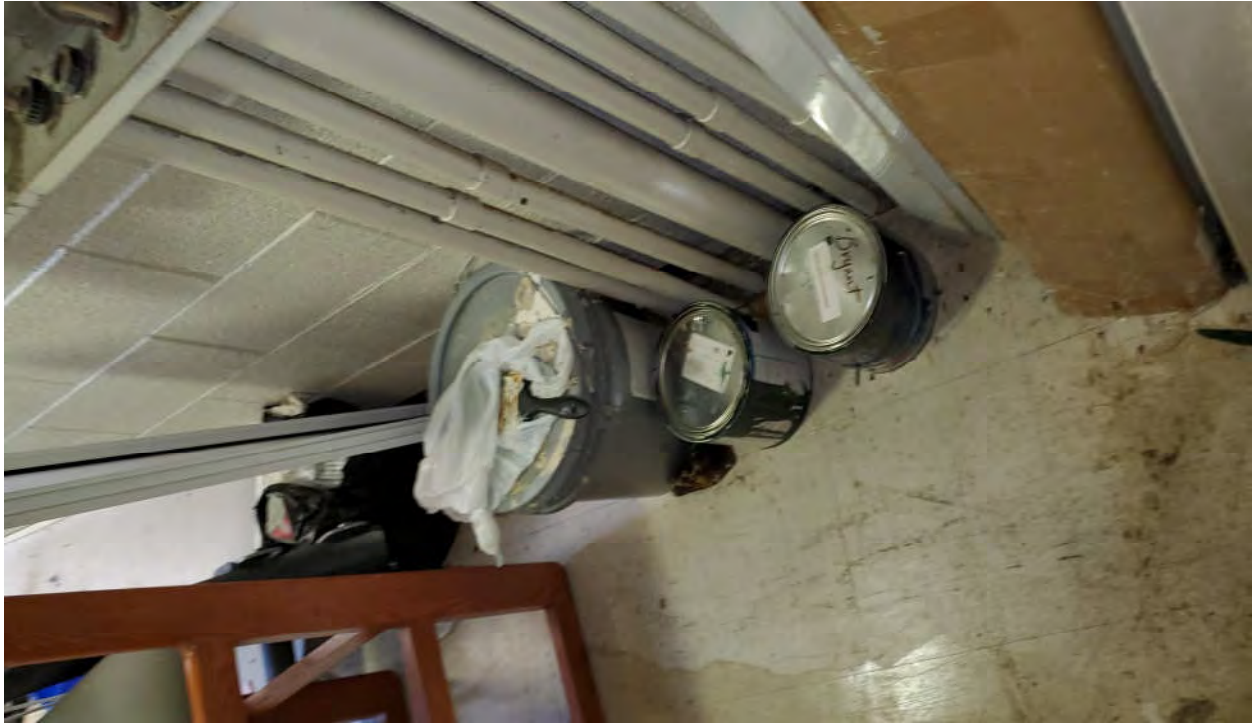
Photograph 7 - Typical Hazardous Waste Containers Including Paints and Cleaning Chemicals Located in the Bryant and Vance Halls.

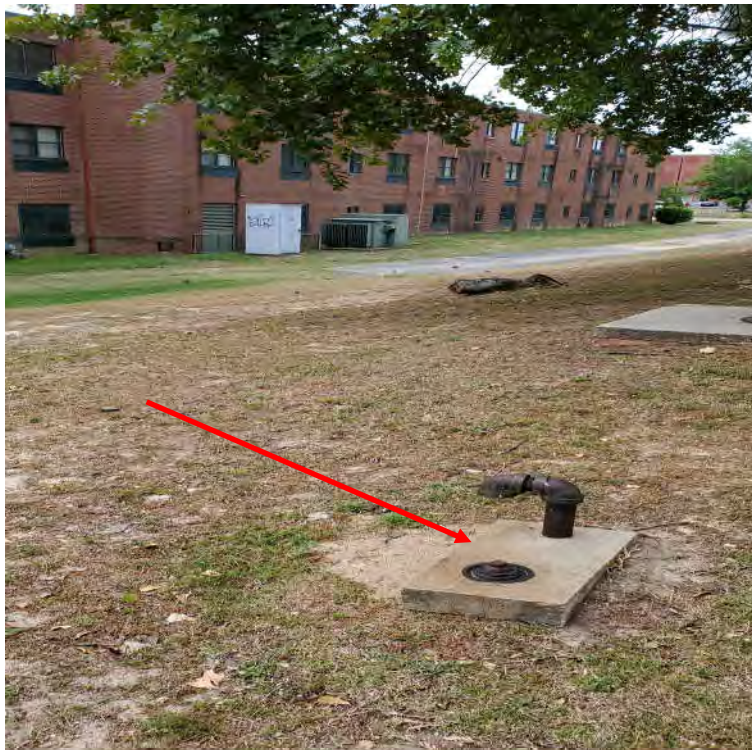
Photograph 8 - Suspect Underground Fuel Storage Tank (UST) Located at the Rear of Vance Hall.
